Pavement Condition Report

Maple Lake Municipal Airport (MGG)

December 2018

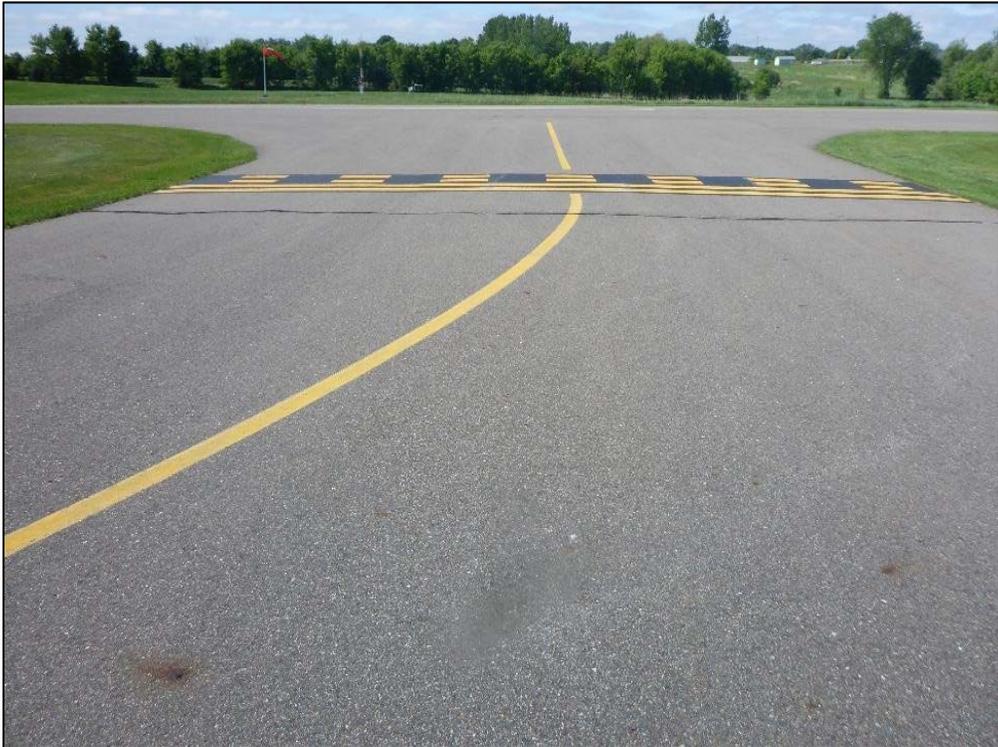
MGG CTA 001 (PCI = 78)

Network:	MGG	Name:	MAPLE LAKE						
Branch:	CTA	Name:	CONNECTING TAXIWAY A	Use:	TAXIWAY	Area:	4,575 SqFt		
Section:	001	of 1	From:	100	To:	100	Last Const.:	8/1/2012	
Surface:	AC	Family:	MN2018 Asphalt Runway- Taxiways	Zone:	E	Category:	2	Rank:	P
Area:	4,575 SqFt	Length:	100 Ft	Width:	40 Ft				
Slabs:		Slab Length:	Ft	Slab Width:	Ft	Joint Length:	Ft		
Shoulder:		Street Type:		Grade:	0	Lanes:	0		
Section Comments:	removed/replace asphalt (PCI was 29)								
Last Insp. Date:	5/31/2018	TotalSamples:	1	Surveyed:	1				
Conditions:	PCI: 78								
Inspection Comments:									
Sample Number:	100	Type:	R	Area:	4575.00 SqFt	PCI:	78		
Sample Comments:									
57	WEATHERING	L	500.00	SqFt					
48	L & T CR	H	6.00	Ft					
48	L & T CR	M	34.00	Ft					
41	ALLIGATOR CR	L	4.00	SqFt

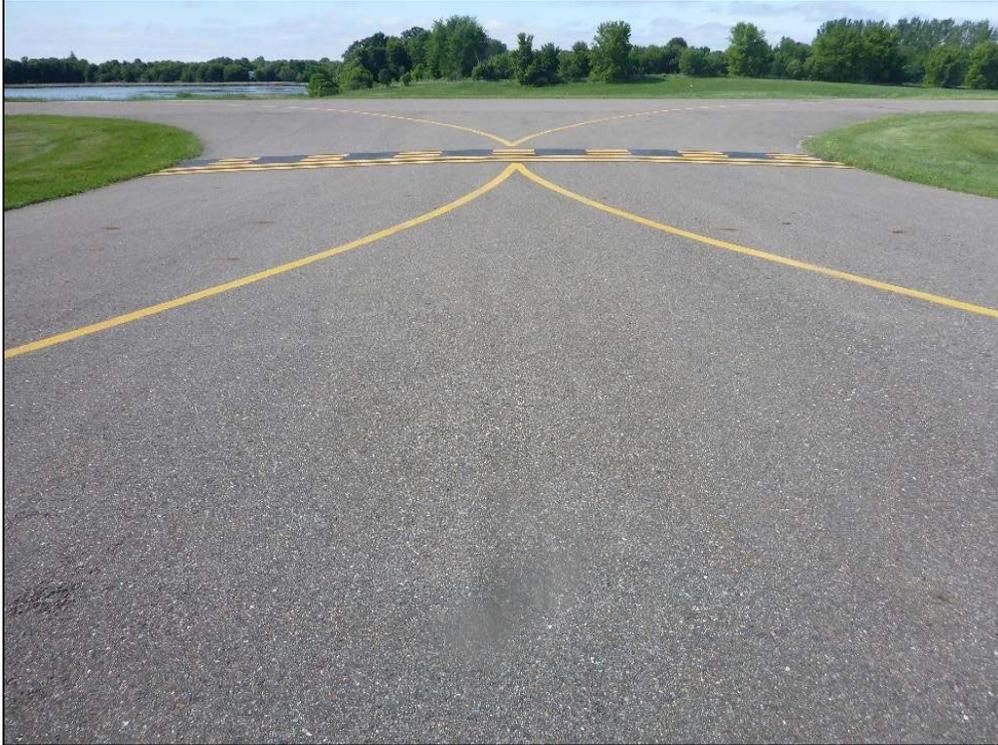
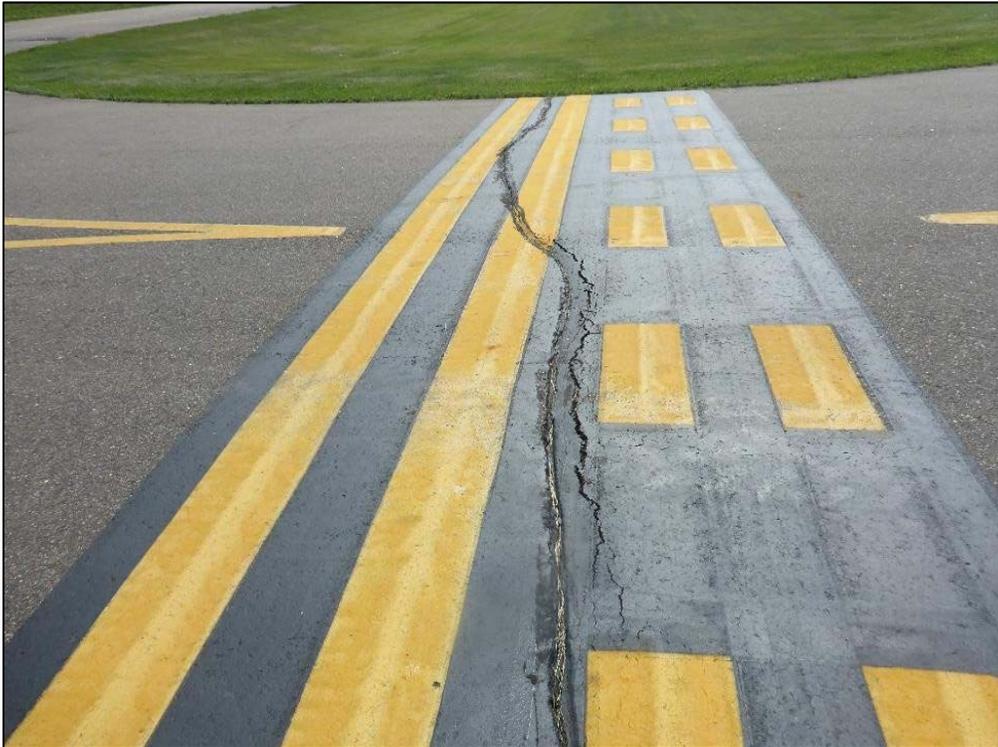
MGG CTB 001 (PCI = 84)

Network:	MGG	Name:	MAPLE LAKE						
Branch:	CTB	Name:	CONNECTING TAXIWAY B	Use:	TAXIWAY	Area:	5,345 SqFt		
Section:	001	of 1	From:	200	To:	200	Last Const.:	8/1/2012	
Surface:	AC	Family:	MN2018 Asphalt Runway- Taxiways	Zone:	E	Category:	2	Rank:	S
Area:	5,345 SqFt	Length:	100 Ft	Width:	40 Ft				
Slabs:		Slab Length:	Ft	Slab Width:	Ft	Joint Length:	Ft		
Shoulder:		Street Type:		Grade:	0	Lanes:	0		
Section Comments:	removed/replace asphalt (PCI was 36)								
Last Insp. Date:	5/31/2018	TotalSamples:	1	Surveyed:	1				
Conditions:	PCI: 84								
Inspection Comments:									
Sample Number:	200	Type:	R	Area:	5345.00 SqFt	PCI:	84		
Sample Comments:									
48	L & T CR	H	8.00	Ft					
57	WEATHERING	L	500.00	SqFt					
48	L & T CR	M	34.00	Ft

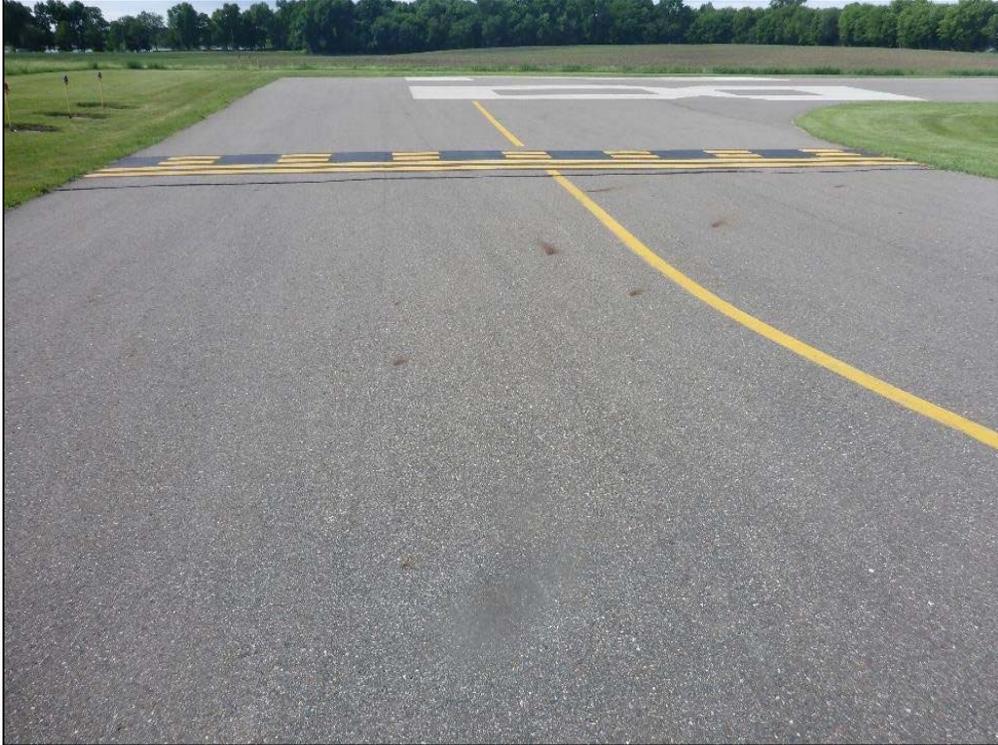
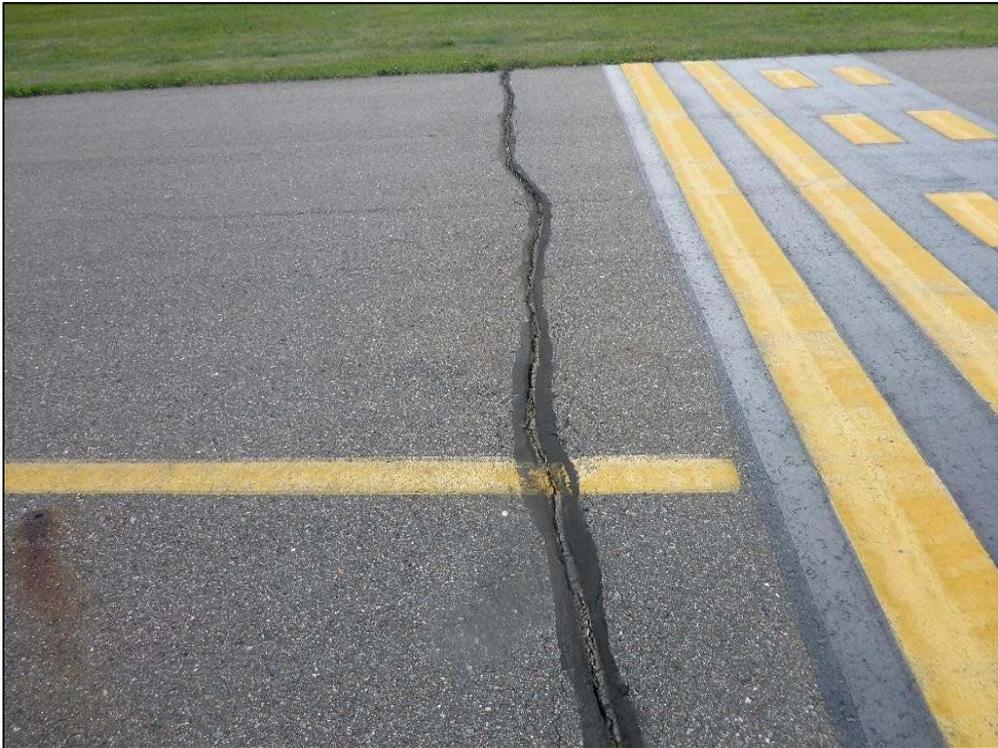
MGG CTC 001 (PCI = 85)

Network:	MGG	Name:	MAPLE LAKE						
Branch:	CTC	Name:	CONNECTING TAXIWAY C	Use:	TAXIWAY	Area:	4,525 SqFt		
Section:	001	of 1	From:	300	To:	300	Last Const.:	8/1/2012	
Surface:	AC	Family:	MN2018 Asphalt Runway- Taxiways	Zone:	E	Category:	2	Rank:	P
Area:	4,525 SqFt	Length:	100 Ft	Width:	40 Ft				
Slabs:		Slab Length:	Ft	Slab Width:	Ft	Joint Length:	Ft		
Shoulder:		Street Type:		Grade:	0	Lanes:	0		
Section Comments:	removed/replace asphalt (PCI was 15)								
Last Insp. Date:	5/31/2018	TotalSamples:	1	Surveyed:	1				
Conditions:	PCI: 85								
Inspection Comments:									
Sample Number:	300	Type:	R	Area:	4525.00 SqFt	PCI:	85		
Sample Comments:									
48	L & T CR	L	10.00	Ft					
48	L & T CR	M	52.00	Ft					
57	WEATHERING	L	500.00	SqFt

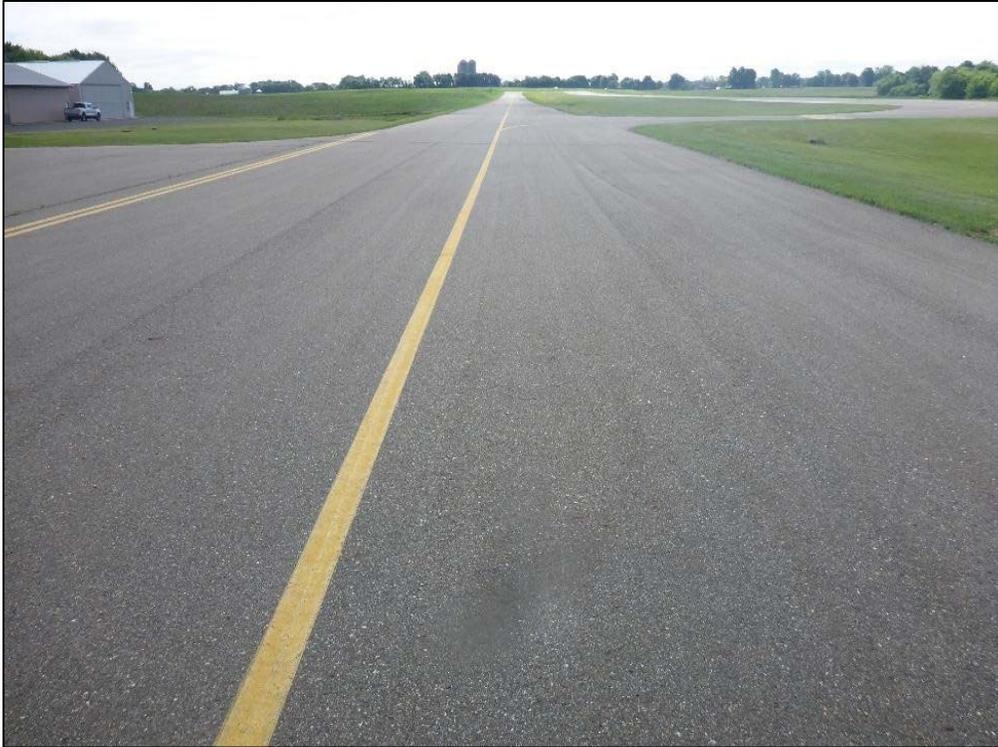
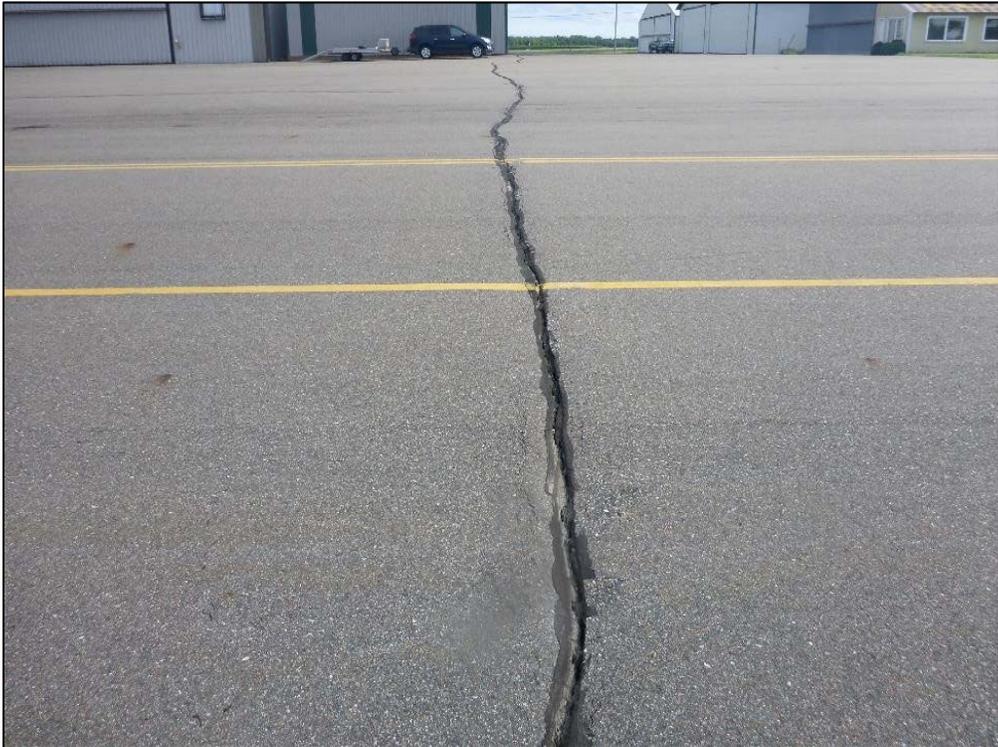
MGG PTA 001 (PCI = 85)

Network:	MGG	Name:	MAPLE LAKE				
Branch:	PTA	Name:	PARALLEL TAXIWAY A	Use:	TAXIWAY	Area:	99,000 SqFt
Section:	001	of 3	From:	100	To:	105	Last Const.: 8/1/2012
Surface:	AC	Family:	MN2018 Asphalt Runway- Taxiways	Zone:	E	Category:	2
Area:	25,120 SqFt	Length:	628 Ft	Width:	40 Ft	Joint Length:	Ft
Slabs:		Slab Length:	Ft	Slab Width:	Ft	Joint Length:	Ft
Shoulder:		Street Type:		Grade:	0	Lanes:	0
Section Comments:	removed/replace asphalt (PCI was 18)						
Last Insp. Date:	5/31/2018	TotalSamples:	6	Surveyed:	2		
Conditions:	PCI: 85						
Inspection Comments:							
Sample Number:	102	Type:	R	Area:	4000.00 SqFt	PCI:	75
Sample Comments:							
48	L & T CR	M	12.00	Ft			
48	L & T CR	H	28.00	Ft			
57	WEATHERING	L	3000.00	SqFt			
Sample Number:	105	Type:	R	Area:	4000.00 SqFt	PCI:	94
Sample Comments:							
57	WEATHERING	L	3000.00	SqFt

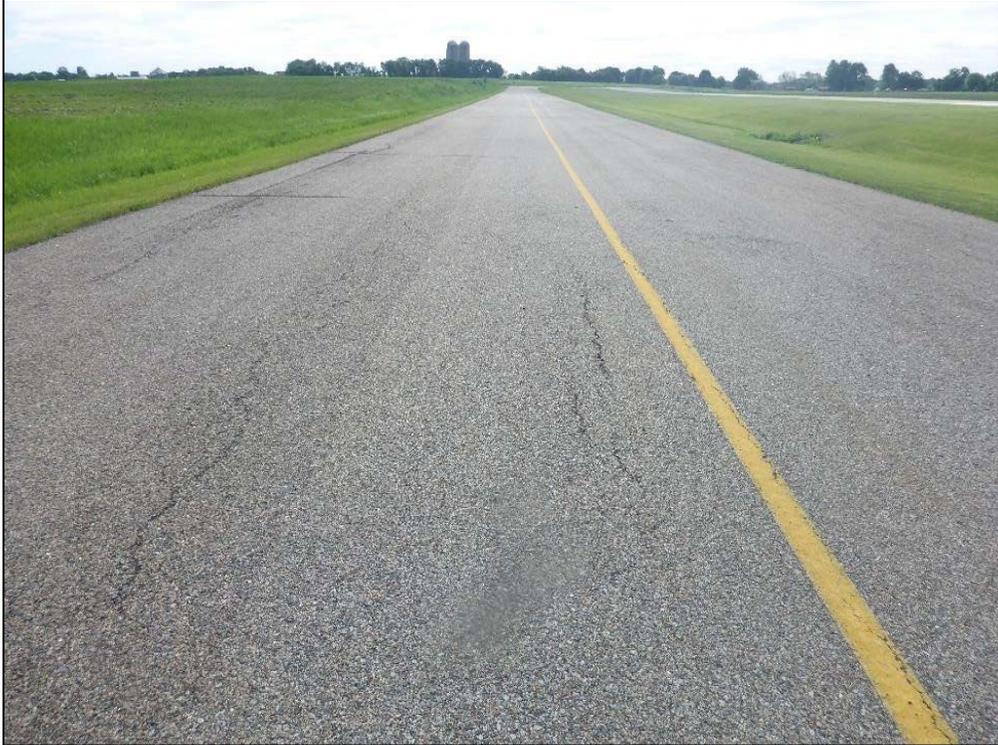
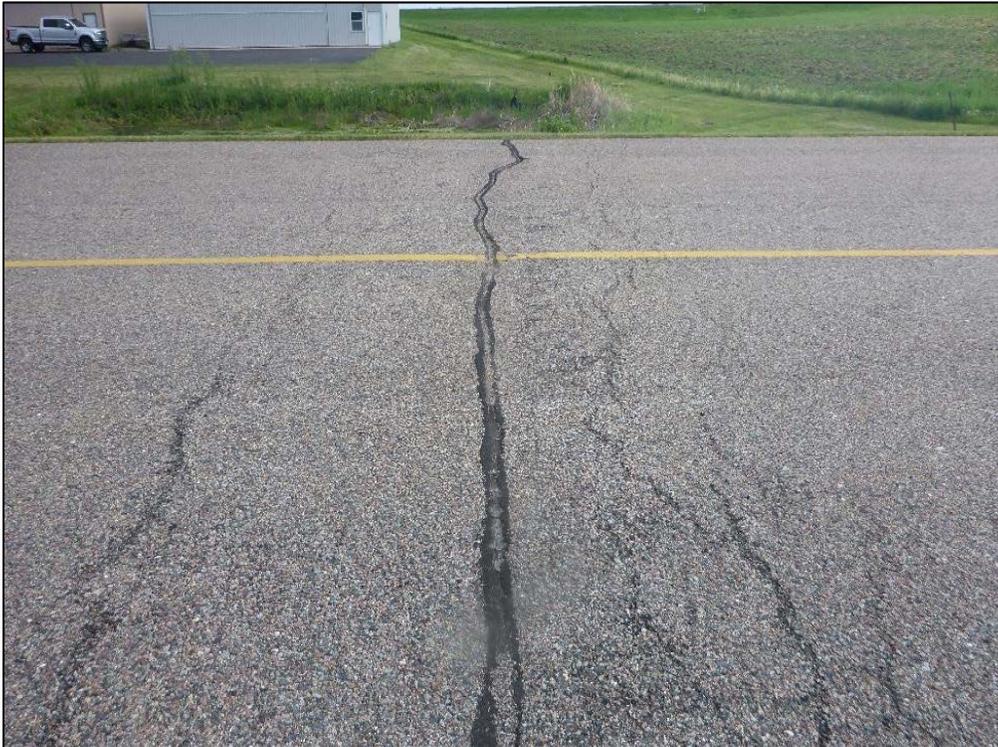
MGG PTA 002 (PCI = 68)

Network:	MGG	Name:	MAPLE LAKE						
Branch:	PTA	Name:	PARALLEL TAXIWAY A	Use:	TAXIWAY	Area:	99,000 SqFt		
Section:	002	of 3	From:	106	To:	123+21	Last Const.:	6/1/2001	
Surface:	AC	Family:	MN2018 Asphalt Runway- Taxiways	Zone:	E	Category:	2	Rank:	P
Area:	67,480 SqFt	Length:	1,687 Ft	Width:	40 Ft				
Slabs:	Slab Length:	Ft	Slab Width:	Ft	Joint Length:	Ft			
Shoulder:	Street Type:	Grade:	0	Lanes:	0				
Section Comments:	pfc surface type								
Last Insp. Date:	5/31/2018	TotalSamples:	17	Surveyed:	4				
Conditions:	PCI: 68								
Inspection Comments:									
Sample Number:	108	Type:	R	Area:	4000.00 SqFt	PCI:	75		
Sample Comments:									
48	L & T CR	L	213.00 Ft						
57	WEATHERING	M	4000.00 SqFt						
Sample Number:	112	Type:	R	Area:	4000.00 SqFt	PCI:	64		
Sample Comments:									
52	RAVELING	L	60.00 SqFt						
57	WEATHERING	M	3900.00 SqFt						
48	L & T CR	L	331.00 Ft						
56	SWELLING	L	8.00 SqFt						
52	RAVELING	M	40.00 SqFt

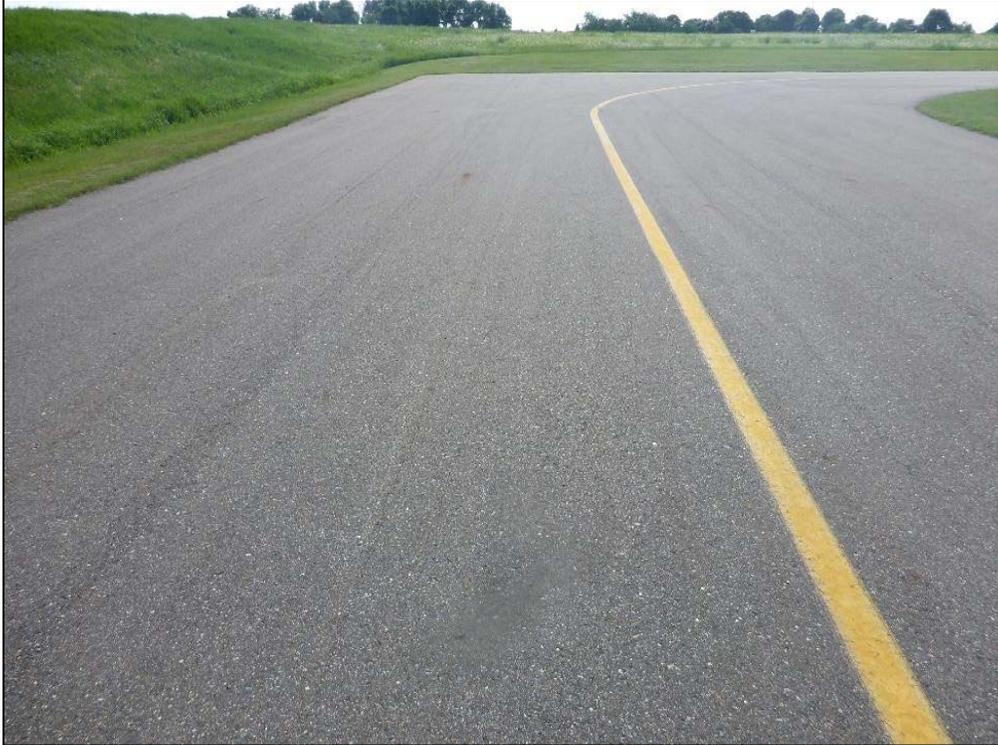
MGG PTA 003 (PCI = 95)

Network:	MGG	Name:	MAPLE LAKE				
Branch:	PTA	Name:	PARALLEL TAXIWAY A	Use:	TAXIWAY	Area:	99,000 SqFt
Section:	003	of 3	From:	123+21	To:	124	Last Const.: 8/1/2012
Surface:	AC	Family:	MN2018 Asphalt Runway- Taxiways	Zone:	E	Category:	2
Area:	6,400 SqFt	Length:	160 Ft	Width:	40 Ft	Joint Length:	Ft
Slabs:		Slab Length:	Ft	Slab Width:	Ft	Joint Length:	Ft
Shoulder:		Street Type:		Grade:	0	Lanes:	0
Section Comments:	removed/replace asphalt (PCI was 23)						
Last Insp. Date:	5/31/2018	TotalSamples:	2	Surveyed:	1		
Conditions:	PCI: 95						
Inspection Comments:							
Sample Number:	123	Type:	R	Area:	3400.00 SqFt	PCI:	95
Sample Comments:							
57	WEATHERING	L	500.00	SqFt			
48	L & T CR	L	5.00	Ft

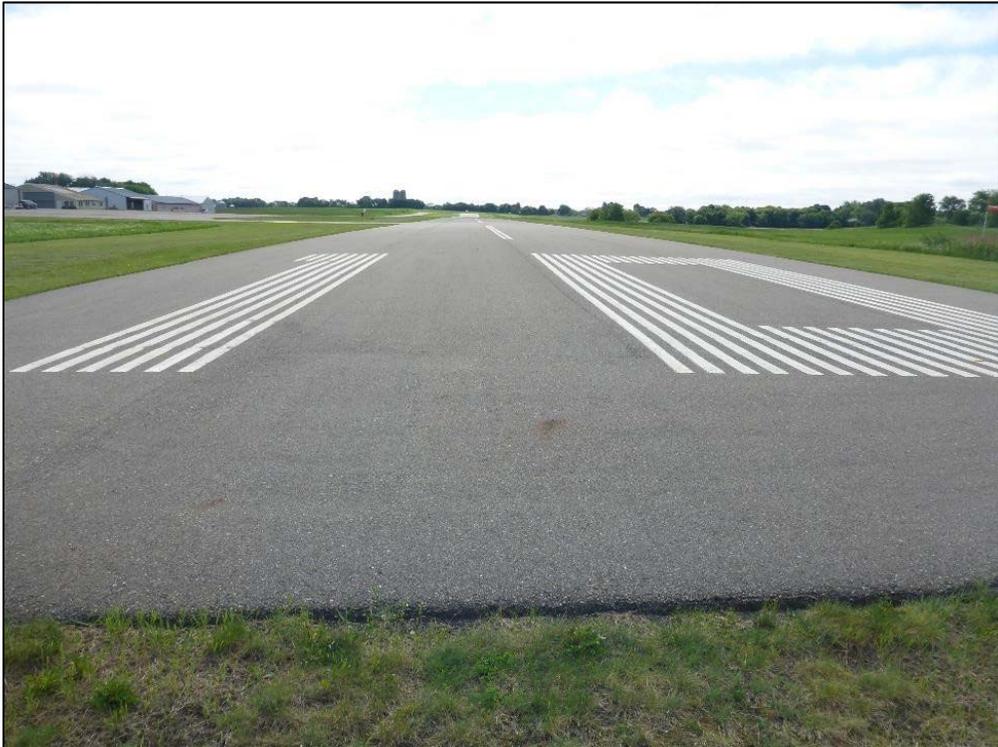
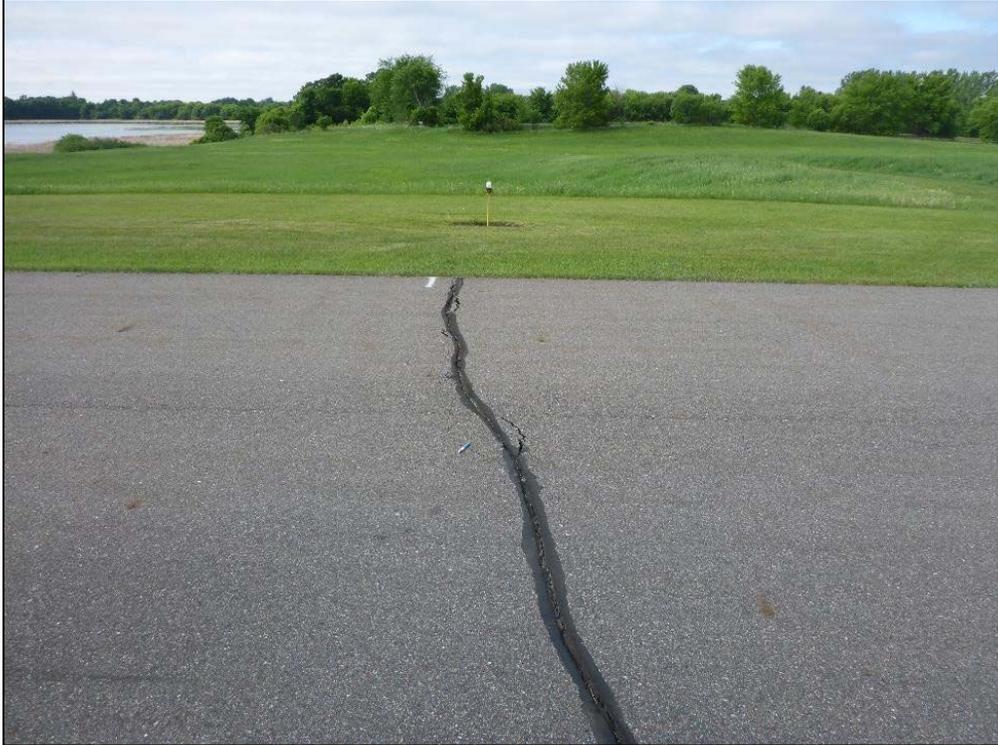
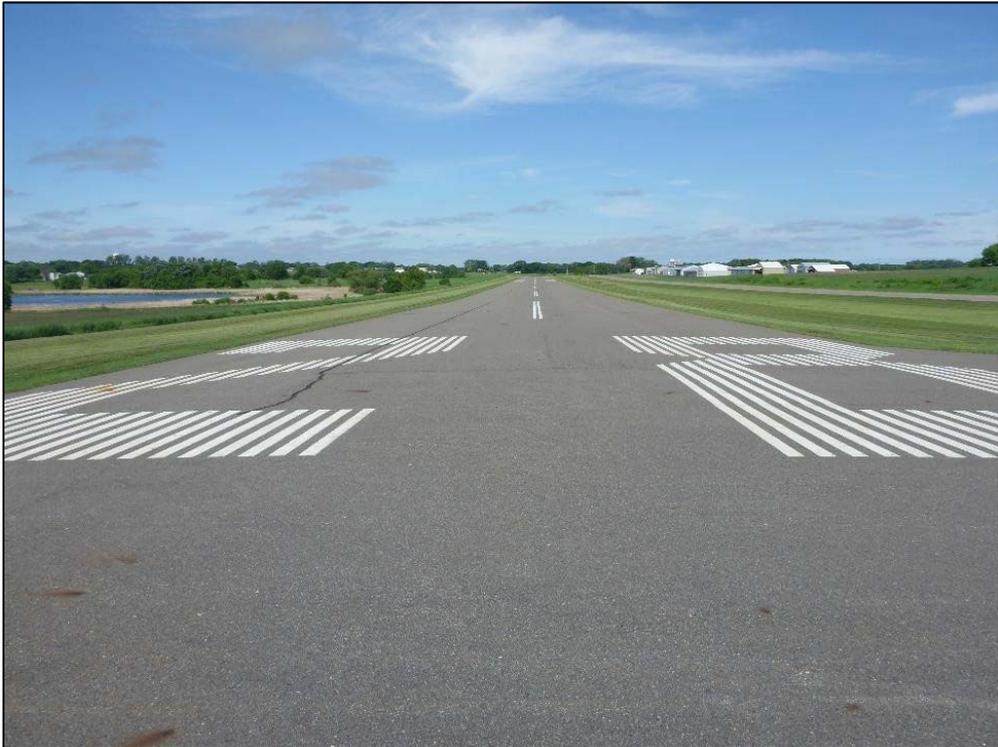
MGG R1028 001 (PCI = 92)

Network:	MGG	Name:	MAPLE LAKE						
Branch:	RY1028	Name:	RUNWAY 10-28	Use:	RUNWAY	Area:	167,760 SqFt		
Section:	001	of 1	From:	100	To:	155	Last Const.:	8/1/2012	
Surface:	AC	Family:	MN2018 Asphalt Runway- Taxiways	Zone:	E	Category:	2	Rank:	P
Area:	167,760 SqFt	Length:	2,796 Ft	Width:	60 Ft				
Slabs:		Slab Length:	Ft	Slab Width:	Ft	Joint Length:	Ft		
Shoulder:		Street Type:		Grade:	0	Lanes:	0		
Section Comments:	reclaimed/overlay (PCI was 19)								
Last Insp. Date:	6/1/2018	TotalSamples:	56	Surveyed:	7				
Conditions:	PCI: 92								
Inspection Comments:									
Sample Number:	104	Type:	R	Area:	3000.00 SqFt	PCI:	85		
Sample Comments:									
57	WEATHERING	L	800.00	SqFt					
48	L & T CR	L	59.00	Ft					
48	L & T CR	M	1.00	Ft					
Sample Number:	113	Type:	R	Area:	3000.00 SqFt	PCI:	97		
Sample Comments:									
57	WEATHERING	L	800.00	SqFt					
Sample Number:	116	Type:	A	Area:	3000.00 SqFt	PCI:	76		
Sample Comments:

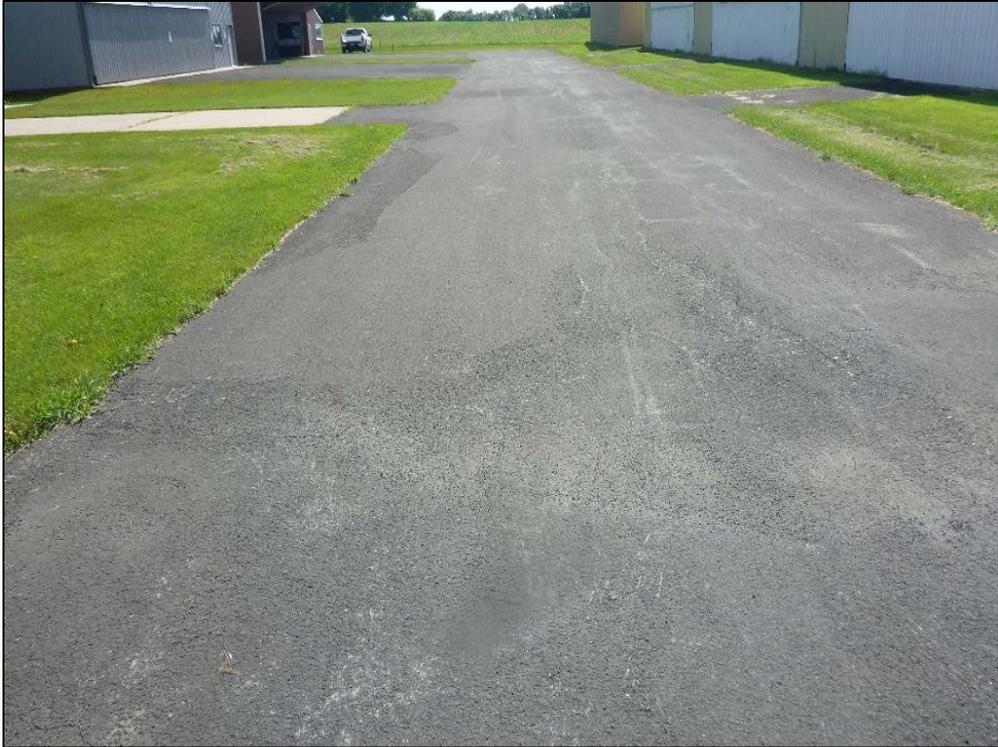
MGG TLA 001 (PCI = 45)

Network:	MGG	Name:	MAPLE LAKE				
Branch:	TLA	Name:	Taxilane A	Use:	TAXILANE	Area:	33,024 SqFt
Section:	001	of 3	From:	100	To:	102	Last Const.: 6/1/1986
Surface:	AC	Family:	MN2018 Asphalt Taxilanes	Zone:	E	Category:	2
Area:	11,900 SqFt	Length:	595 Ft	Width:	20 Ft	Joint Length:	Ft
Slabs:		Slab Length:	Ft	Slab Width:	Ft	Joint Length:	Ft
Shoulder:		Street Type:		Grade:	0	Lanes:	0
Section Comments:	estimated LCD						
Last Insp. Date:	5/31/2018	TotalSamples:	3	Surveyed:	2		
Conditions:	PCI: 45						
Inspection Comments:							
Sample Number:	101	Type:	R	Area:	3500.00 SqFt	PCI:	60
Sample Comments:							
41	ALLIGATOR CR	M	32.00	SqFt			
41	ALLIGATOR CR	L	36.00	SqFt			
48	L & T CR	L	217.00	Ft			
Sample Number:	200	Type:	R	Area:	4000.00 SqFt	PCI:	31
Sample Comments:							
41	ALLIGATOR CR	L	70.00	SqFt			
45	DEPRESSION	L	42.00	SqFt			
43	BLOCK CR	M	640.00	SqFt			
56	SWELLING	M	45.00	SqFt			
45	DEPRESSION	M	10.00	SqFt

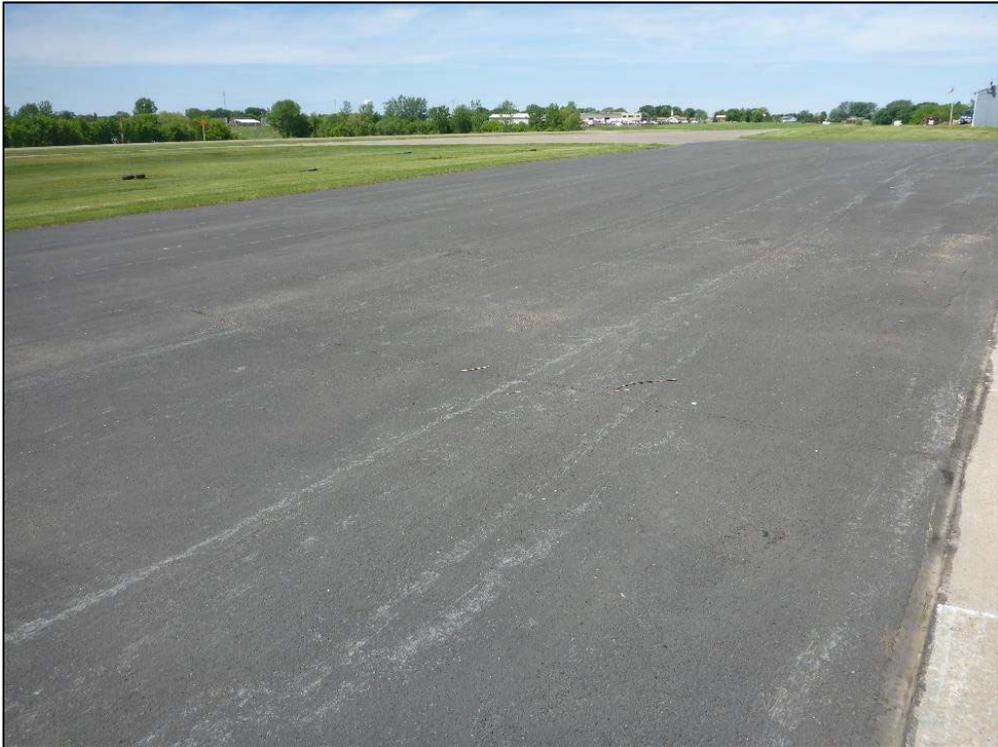
MGG TLA 002 (PCI = 48)

Network:	MGG	Name:	MAPLE LAKE						
Branch:	TLA	Name:	Taxilane A	Use:	TAXILANE	Area:	33,024 SqFt		
Section:	002	of 3	From:	100	To:	103	Last Const.:	6/1/2004	
Surface:	AAC	Family:	MN2018 Asphalt Taxilanes	Zone:	E	Category:	2	Rank:	T
Area:	18,360 SqFt	Length:	340 Ft	Width:	54 Ft				
Slabs:		Slab Length:	Ft	Slab Width:	Ft	Joint Length:	Ft		
Shoulder:		Street Type:		Grade:	0	Lanes:	0		
Section Comments:	estimated LCD								
Last Insp. Date:	6/1/2018	TotalSamples:	4	Surveyed:	1				
Conditions:	PCI: 48								
Inspection Comments:									
Sample Number:	101	Type:	R	Area:	5400.00 SqFt	PCI:	48		
Sample Comments:	slurry seal since last inspections								
43	BLOCK CR	L	252.00	SqFt					
41	ALLIGATOR CR	M	115.00	SqFt					
48	L & T CR	M	40.00	Ft					
48	L & T CR	L	210.00	Ft
