# Field Review Memo: Mastic and Crack Seal Performance 2017

Observations taken March 1 and 2, 2017.

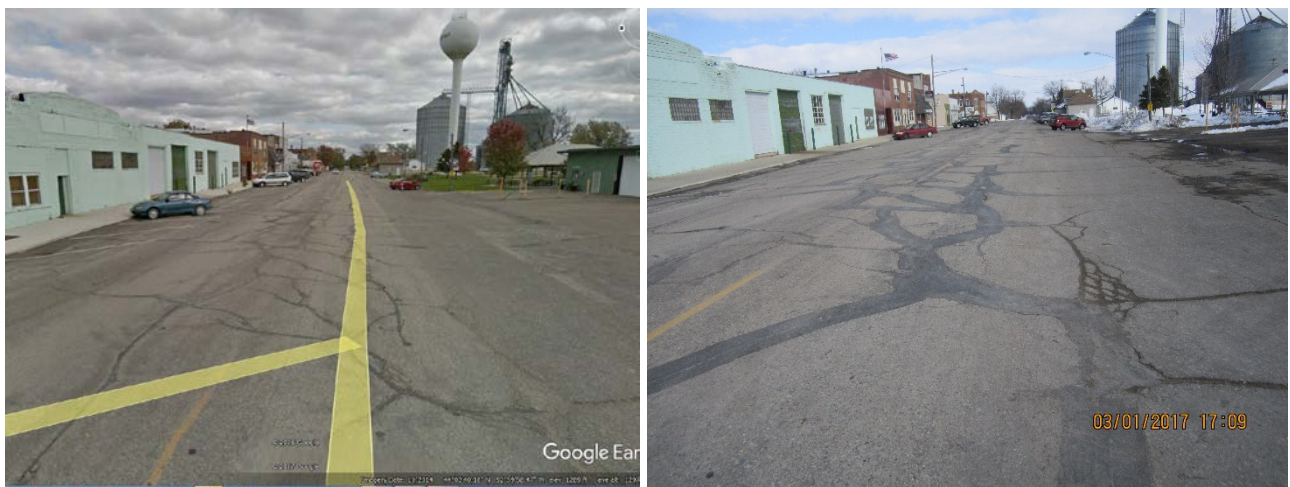
County Road 3 (Front Street): Bituminous, block cracking, previously cracksealed. Extensive mastic treatment applied in 2006 by city forces. On this date the mastic was semi-rigid to the touch, and a coin could penetrate approximately 1/8 inch. On this date ride was satisfactory. Evidence of some crack growth was observed. Drainage adequacy may be an issue on this site.

Figure 1 (Left) County Road 3 in 2014, prior to mastic. (Right) In 2017, after mastic.

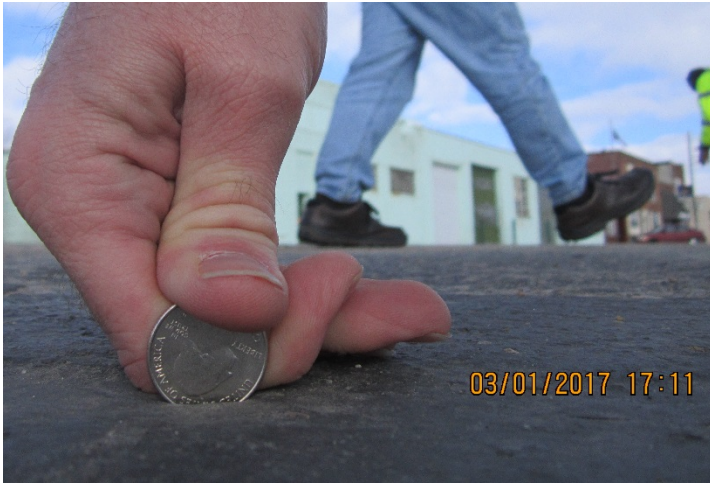
Figure 2 "Coin test" of mastic repair.

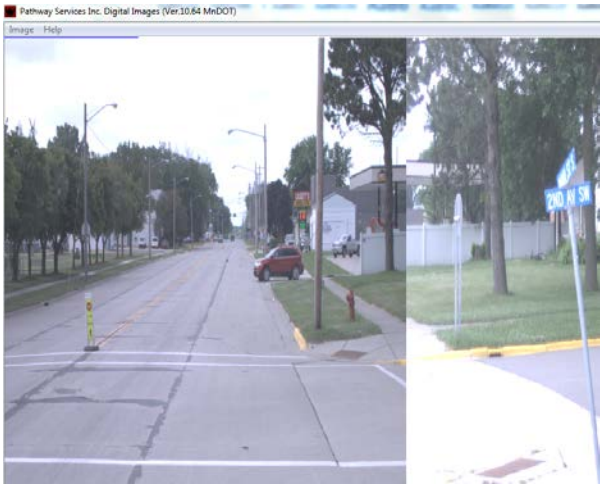
United States Trunk Highway 169 in Winnebago between 2<sup>nd</sup> Ave. SW and 3<sup>rd</sup> Ave. SW RP 19.85: Concrete, potholes and other deterioration associated with Alkali Silica Reaction. Variety of crack seal, mastic, and bituminous patching treatment exist throughout the city, various ages. Mastic was applied approximately 2015 – 2016 by MnDOT district maintenance forces. On this date the mastic sealant showed good performance; some treatments were 0.5ft deep or greater in irregular holes at corners and joints . Ride was satisfactory.

Figure 3 US 169 in Winnebago, Mastic patches 2016.

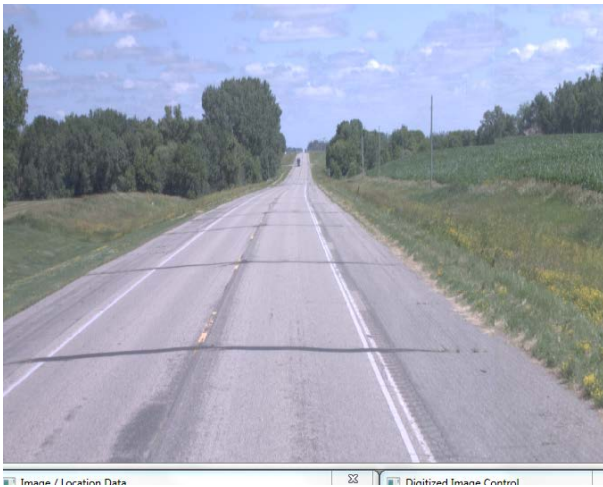
Multiple formulations of mastic material was tried on Bituminous: transverse cracked full-depth asphalt, and Concrete ramps: sound joints with panel breaks. District forces installed material between 2016 – 2017. The installation involved trying various aggregate sizes, formulations of the hot melt component, and kettle temperatures. Material that had been overheated was still able to perform, but had a sunken appearance. Ride was satisfactory.

Figure 4 Mastic treatment on MN TH15.

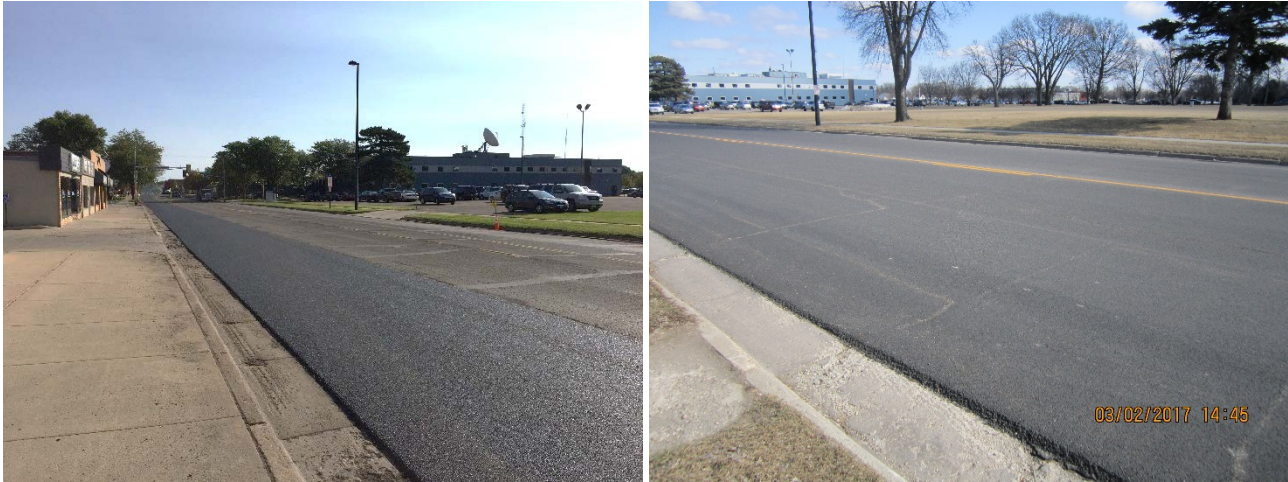
Minnesota Trunk Highway 19 received a Mill-Overlay using Ultra Thin Bonded Wearing Course in 2016. Bituminous: as preparation to overlay, mastic material was used to dress the transverse cracks and any holes in

the milled surface. It was observed that reflective cracking had occurred during the first winter, and that the aggregates around the cracks appeared to be exposed to damage by snow plowing; indicating possible localized heaving, or tenting of cracks. Ride was satisfactory.

Figure 5 Minnesota Trunk Highway 15: (Left) during 2016 UTBWC mill and overaly, (Right) spring 2017.

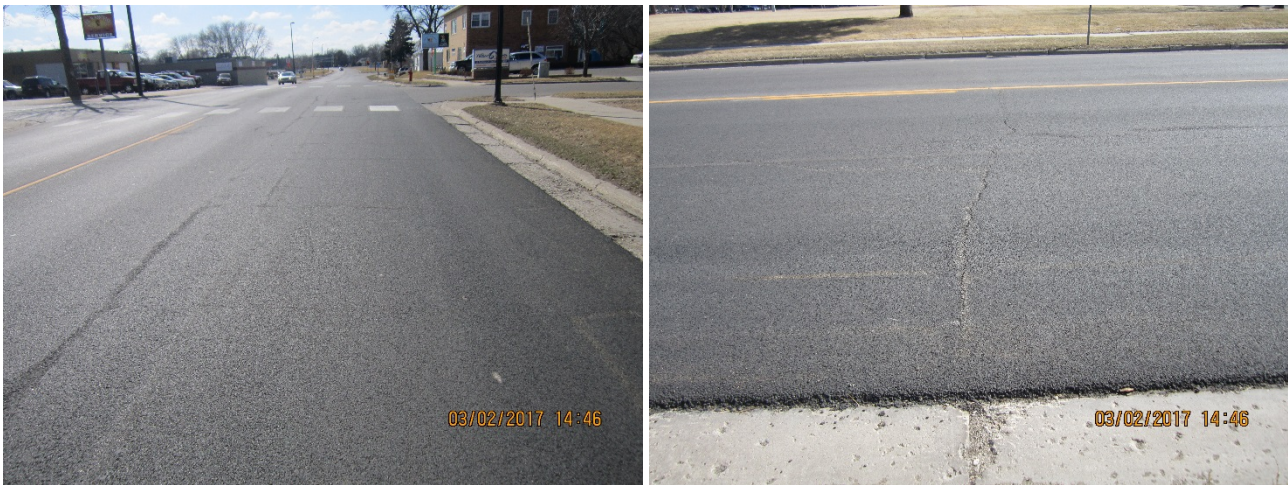
Figure 6 Minnesota Trunk Highway 19, 2017 performance of UTBWC mill and overaly in Marshall, MN
