MANTORVILLE RETAINING WALLS

SHPO INV. # DO-MTC-038

Survey Date: October 7, 2002

Appendix C
HDR Condition Assessment Notes
Mantorville Retaining Walls

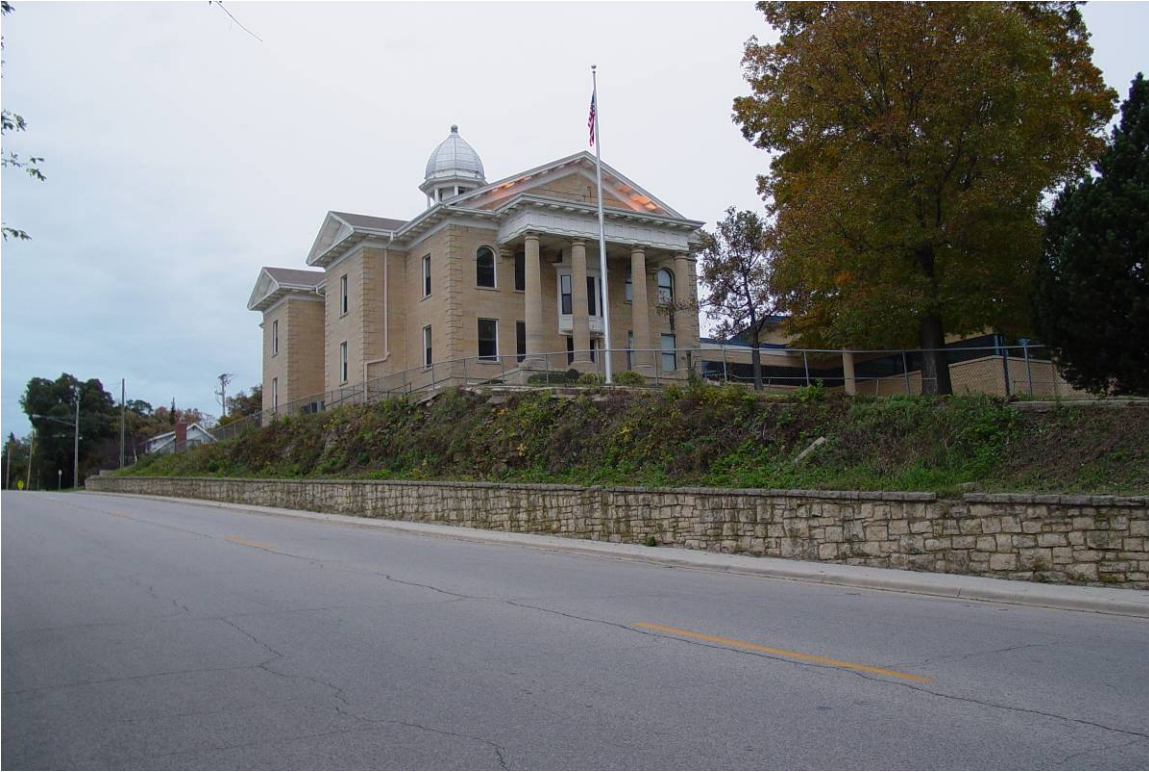
Plate 1. East retaining wall and Dodge County courthouse, facing northeast

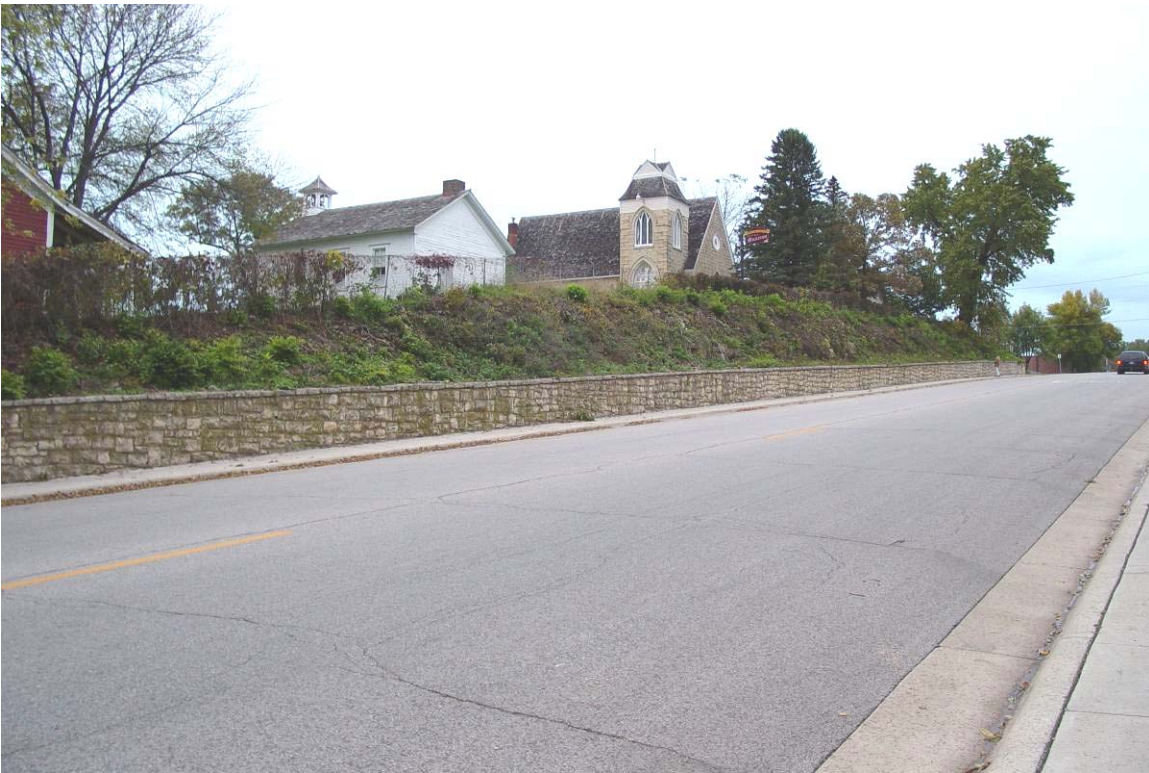
Plate 2. West retaining wall and adjacent historic properties, facing northwest

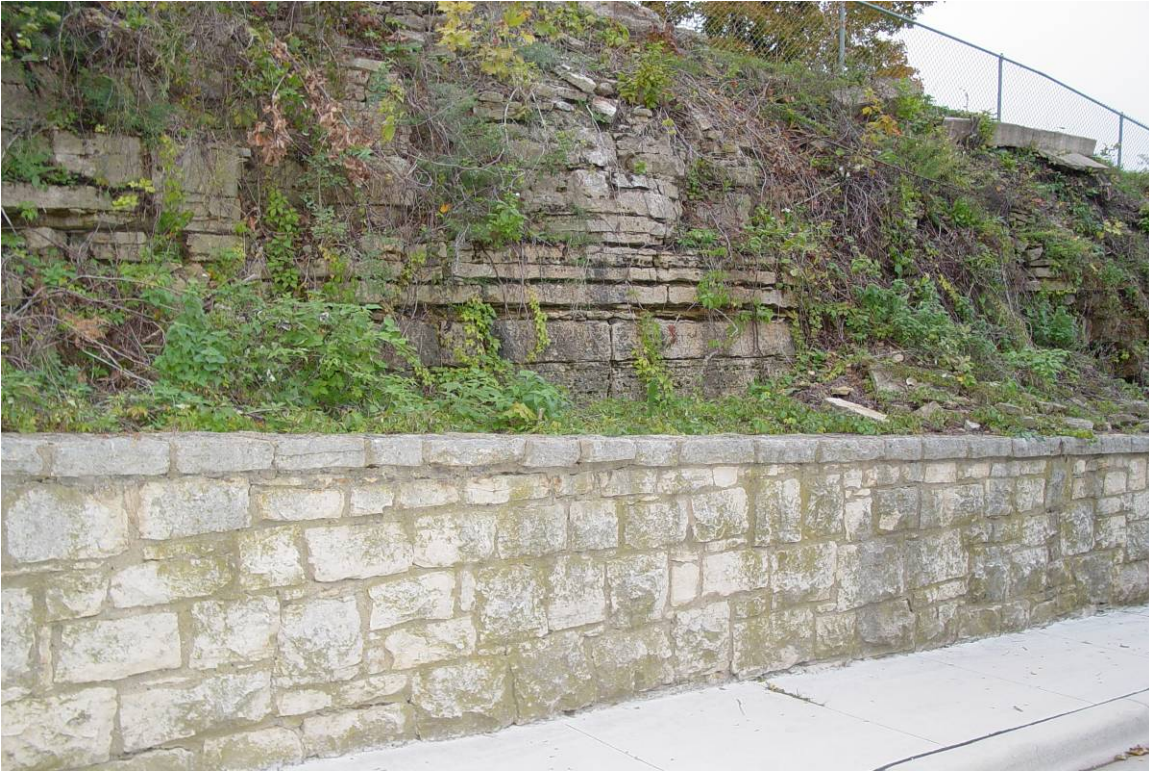
- **Assessment:** TH 57 is steeply inclined on this block, but the masonry of both walls has been laid in a level fashion to provide stability. The steep streetscape and rock-faced limestone walls provide a pleasing visual complement to the adjacent courthouse and other historic buildings. The limestone outcrops flanking each wall display a moderate amount of erosion, and there are a large number of limestone fragments which may threaten pedestrian traffic on the sidewalks below. In addition, the configuration of the limestone outcrop above the east wall creates significant challenges for properly draining storm water.

Plate 3. East retaining wall, showing typical orientation to limestone exposure, facing southeast

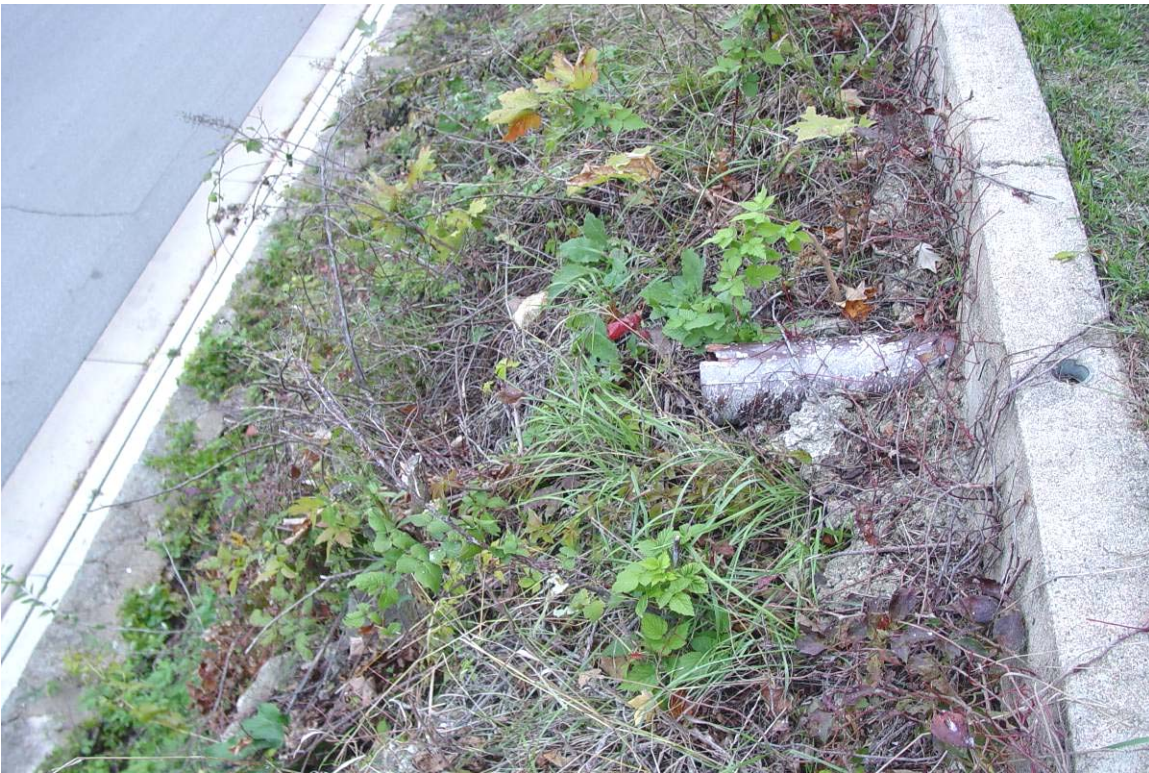
Plate 4. East retaining wall, drainage pipe from Dodge County courthouse downspouts, facing north

- Preservation:** Delay further erosion of the east limestone outcrop by diverting storm water from the courthouse property away from outcrop face. This may be possible through the diversion of the courthouse's existing drainage pipe system from the face, and the installation of a low-profile surface drain system at the top of the outcrop which drains to the city sewer (as discussed and estimated under 6. *Structures, Furnishings, and Objects/a. Stone Retaining Walls/East Retaining Wall*). **Work Period:** 1 year.

East Retaining Wall: Remove loose and missing limestone and concrete debris from the limestone outcrops above the wall. Replace missing masonry units with those remaining on site, or provide matching replacements from a new source. Repair and repoint the leaning masonry at the north end of the wall with a Type N (750 PSI) mortar and match the original mortar color. Remove the encroaching vegetation from the top of the wall (cost estimate listed under *Vegetation*). Reroute the existing storm water drainage pipe from the courthouse to avoid saturating the soils behind the wall (possibly by connecting PVC pipe to the west courthouse drainpipe and routing it above-ground to city sewer) (cost estimates listed under *Retaining wall*). **Work Period:** 1 year.

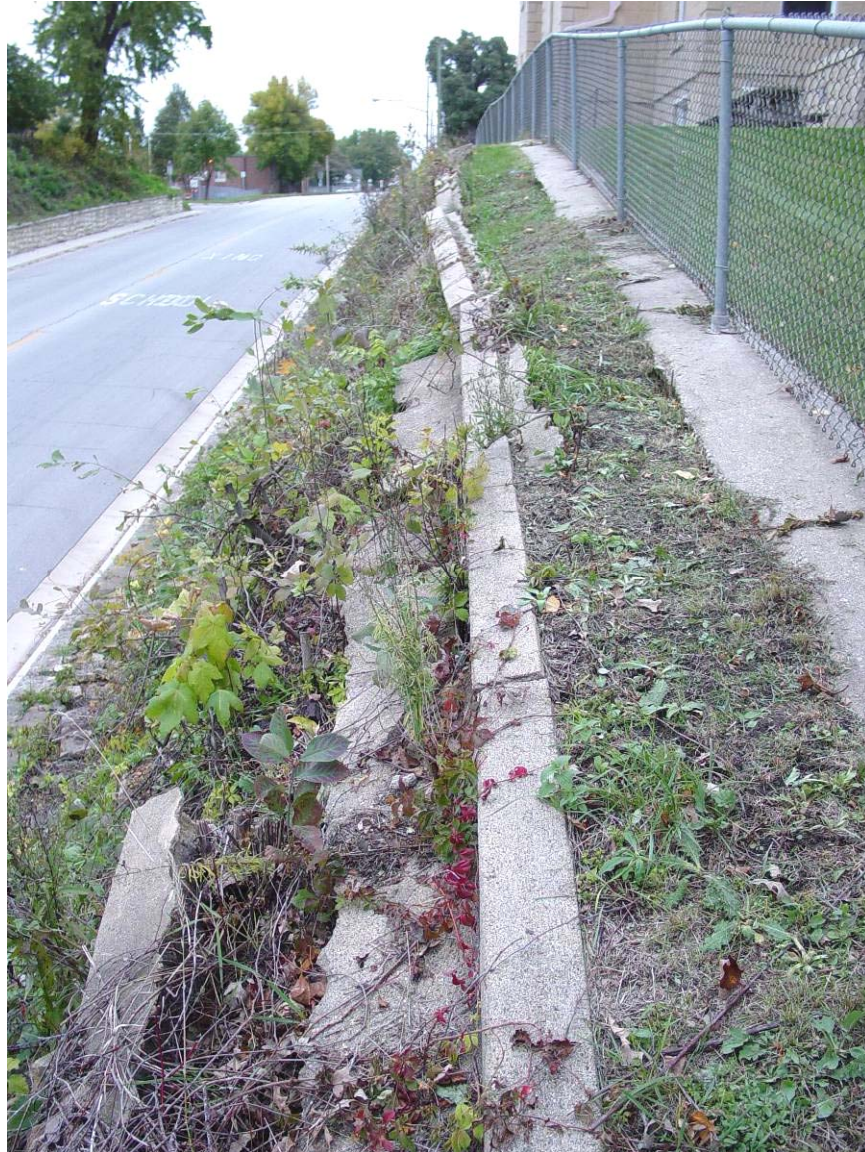
- Assessment: Field examination of the eastern retaining wall revealed the fragmented remains of a formed concrete gutter that may be contemporary with the wall. Its location suggests that it was not meant to be visible from the sidewalk. Designed to prevent storm water from the courthouse property from flowing down behind the retaining wall masonry, the gutter ran along nearly the entire length of the top edge of the limestone outcrop. This water was then presumably drained into the street at the south end of the east wall. Since this gutter no longer functions, storm water from the courthouse property is diverted through an underground pipe, exiting at a point several feet down the face of the limestone outcrop. The pipe and the general slope of the outcrop currently channel water into the soil behind the east wall.

Plate 5. East retaining wall, deteriorated concrete gutter system, facing north

- Recommendations:
Stabilization: Remove portions of the concrete gutter which are in danger of falling onto the sidewalk below (cost estimate listed under *Health and Safety Considerations*). Work Period: Immediately.
Preservation: None. Work Period: Not applicable.
Restoration: A strict restoration would recreate the original formed concrete gutter and install it at the top edge of the east limestone outcrop. Restoration of this original drainage system is not likely to be practical, since municipal code undoubtedly would not allow the unchanneled discharge of storm water at the south end of the wall. *Rerouting the water is discussed and estimated under Retaining wall.* Work Period: Not applicable.

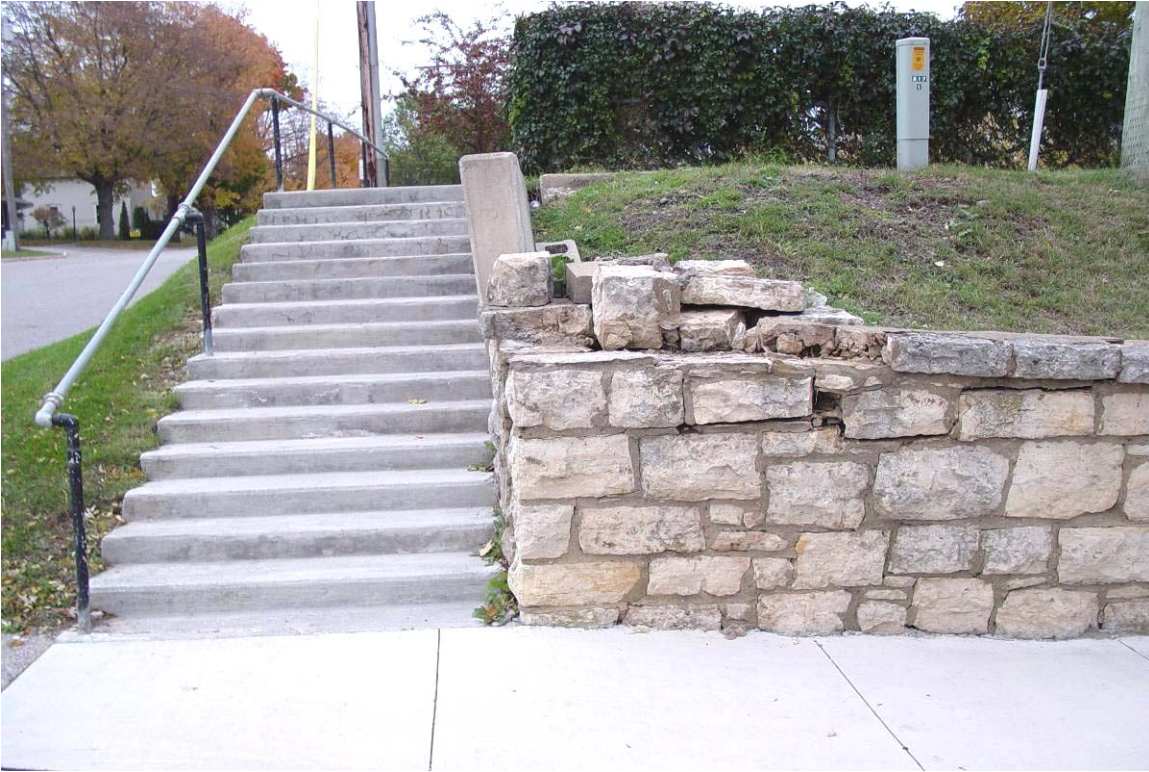
There are steps at the north ends of both retaining walls, and at the south end of the west wall. The east wall's north steps and a short section of the wall extending east at this point have been replaced by formed concrete. The west wall's north and south steps (both fashioned from dressed limestone slabs) remain in their original configuration.

East Retaining Wall: The original steps at the north end of the wall lead to the rear parking lot of the courthouse, and have been replaced by concrete. The adjacent section of stone wall is leaning slightly toward the street. An 8'-long formed concrete east extension of this wall retains the hillside on the south side of the steps and is leaning over the steps approximately 3" out of plumb.

Plate 6. Northeast concrete steps, with leaning stone and concrete retaining walls, facing east

a depth of at least 2" and repoint with Type N mortar to match original mortar color. Remove the existing concrete steps at the north end of the east wall and replace with limestone masonry slab steps, dressed to match those at the north end of the west wall (across TH 57)(cost estimates listed under *Steps: East Wall Restoration*). Structurally secure the leaning central portion of the wall by trenching behind the wall, replumbing the masonry, and installing anchors to the limestone bedrock. If dismantling and rebuilding a portion of the wall is required to replumb the structure, ensure that the masonry pattern and mortar joints match the original configuration. Add clean soil at the south end of the wall to cover and protect the base course of masonry and lay sod (cost estimate listed under *Retaining Wall*). Reroute the courthouse storm drainage through the base of the wall to the city sewer system. Backfill the trench with a rapid-draining granular matrix. Remove concrete pyramidal finial at southern pier and replace with gray example similar to the finial at the pier on the west retaining wall. **Work Period:** 3 - 5 years.

East Retaining Wall: Remove leaning formed concrete retaining wall extension at north steps of east wall and install new concrete wall. Anchor new wall back to hillside and install rough-faced limestone veneer visually sympathetic to existing wall. Remove the existing concrete steps and replace with limestone masonry slab steps, dressed to match those at the north end of the west wall (across TH 57)(all cost estimates listed under *Steps: East Wall Restoration*).

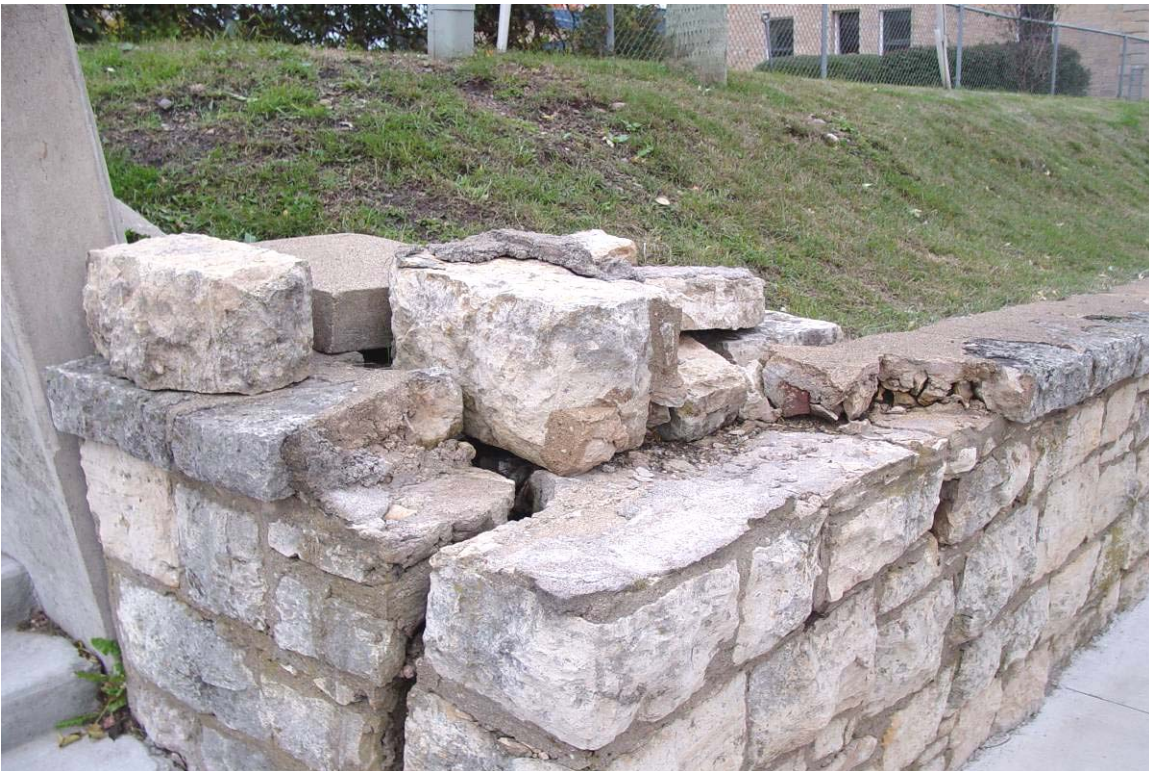
East Retaining Wall: Overall structural condition is good, although there is leaning masonry at the north end near the concrete steps and subsiding masonry at the south end wall return. The landscaping at the south end of the wall has eroded and begun to expose the base course of masonry. There are several missing masonry units across the length of the wall. The structural integrity of approximately 200' of the wall's central section has been compromised by the infiltration of storm water from the Dodge County courthouse and the limestone outcrop, causing it to lean toward TH 57 by as much as 4". The pyramidal finial at southern pier, originally of gray limestone construction, has been replaced with a poured concrete example.

Plate 7. North end of east retaining wall, damaged stone, facing southeast

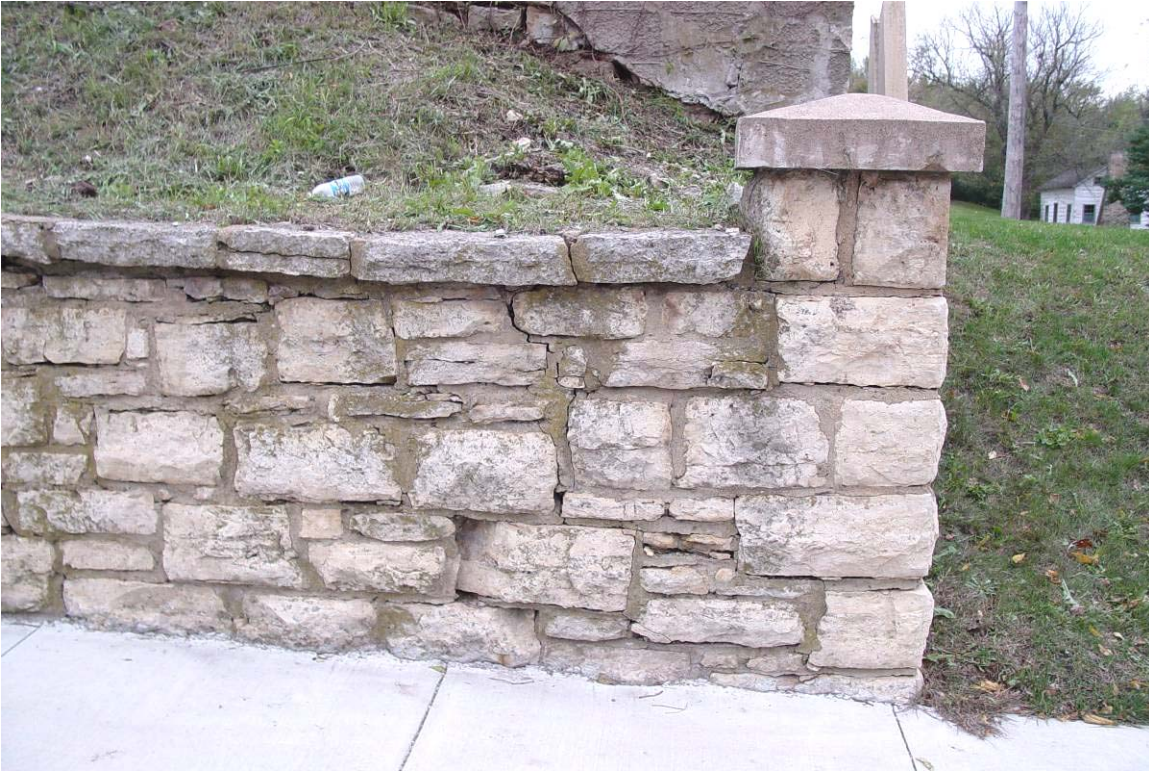
Plate 8. East retaining wall, south end, facing east

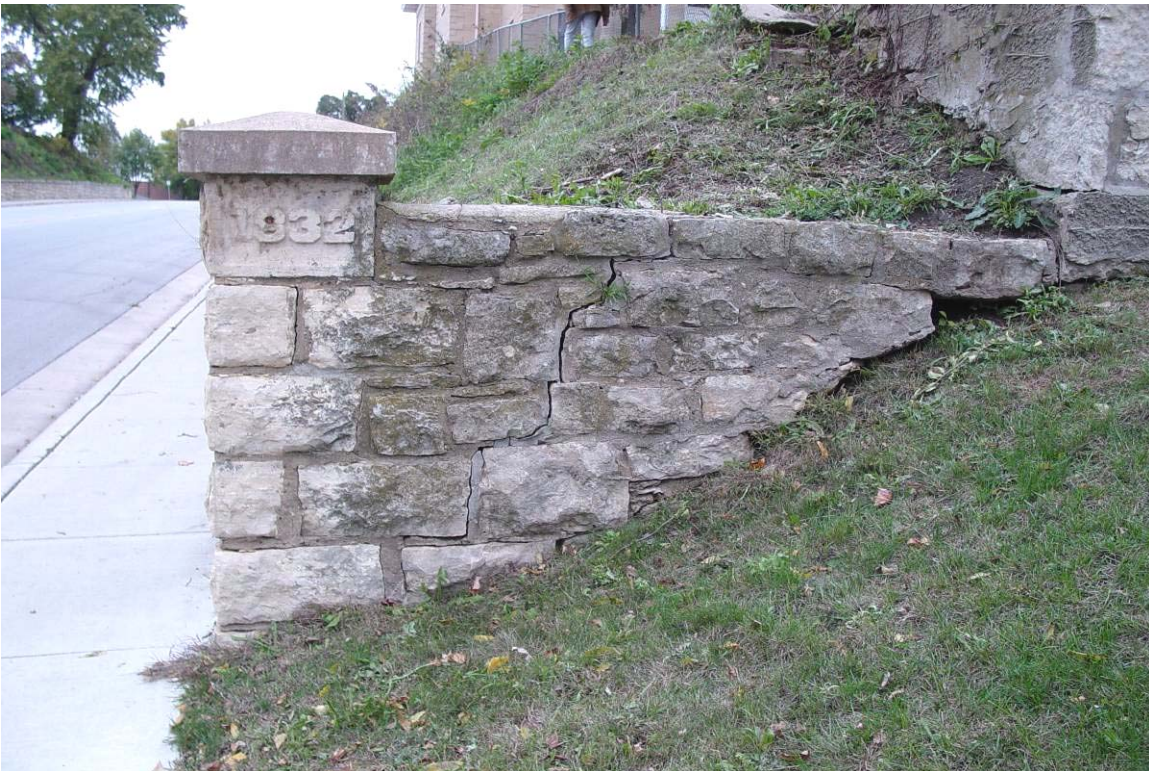
Plate 9. East retaining wall, south end, facing north

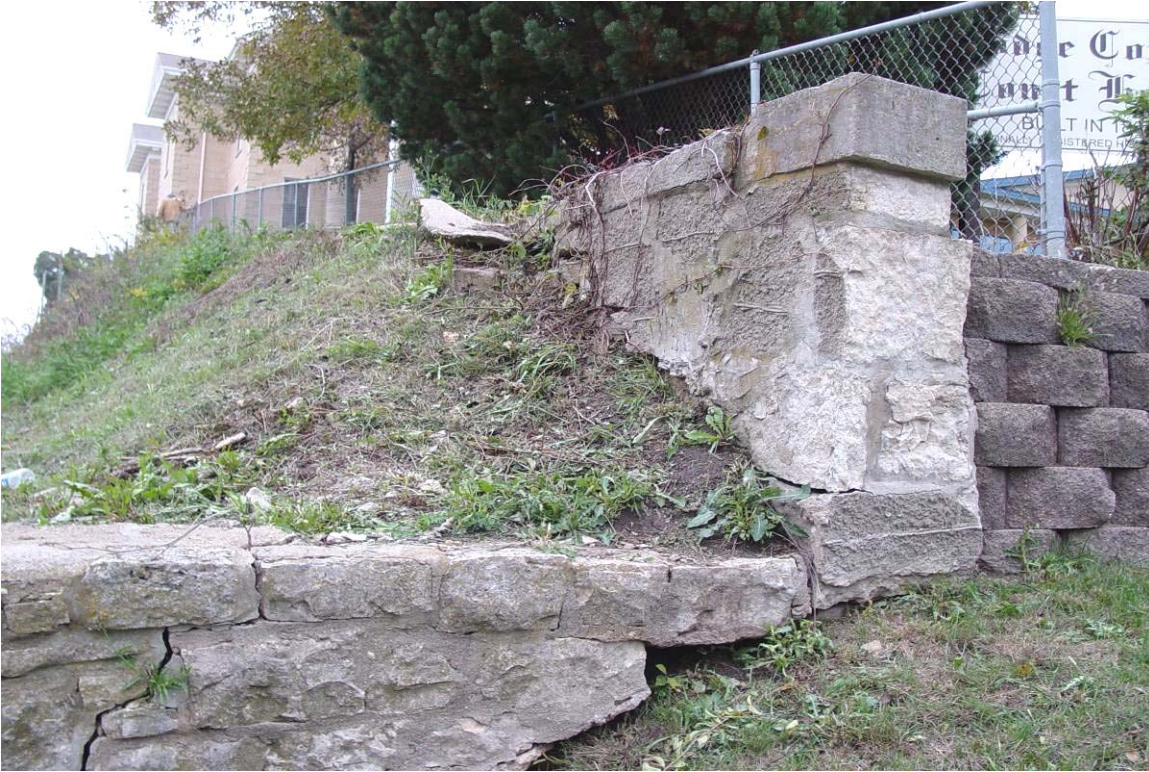
Plate 10. East retaining wall, south end juncture with adjacent retaining walls, facing northeast

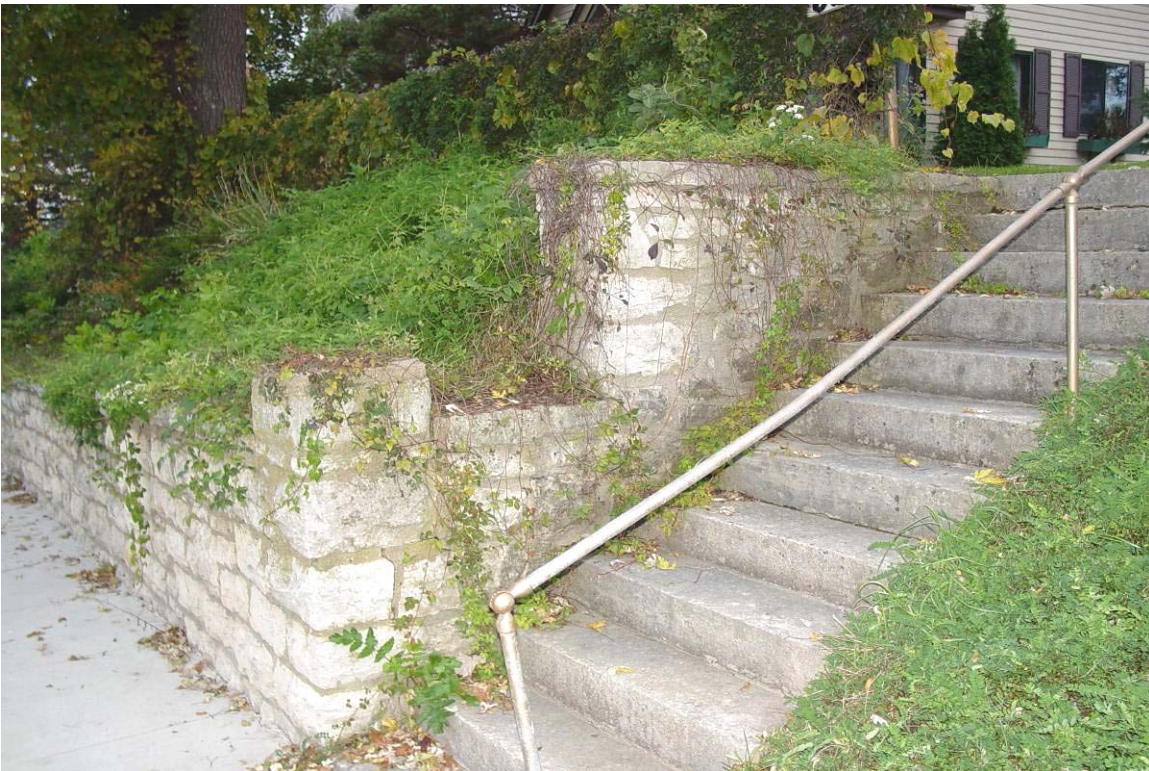
West Retaining Wall: The dressed masonry steps at the north and south ends serve two of the properties owned by the Dodge County Historical Society. The north steps are in good condition, with a few surficial cracks. The south steps are in fair to poor condition: the top step has fractured in the center, there is general settling of the other steps, and eroded soil and herbaceous weeds on the edges of the steps.

Plate 11. West retaining wall, north stone steps, facing southwest

West Retaining Wall: Remove herbaceous weeds from the north steps. Remove eroded soil and herbaceous weeds from the south steps (cost estimates listed in *Vegetation*). **Work Period:** Immediately.

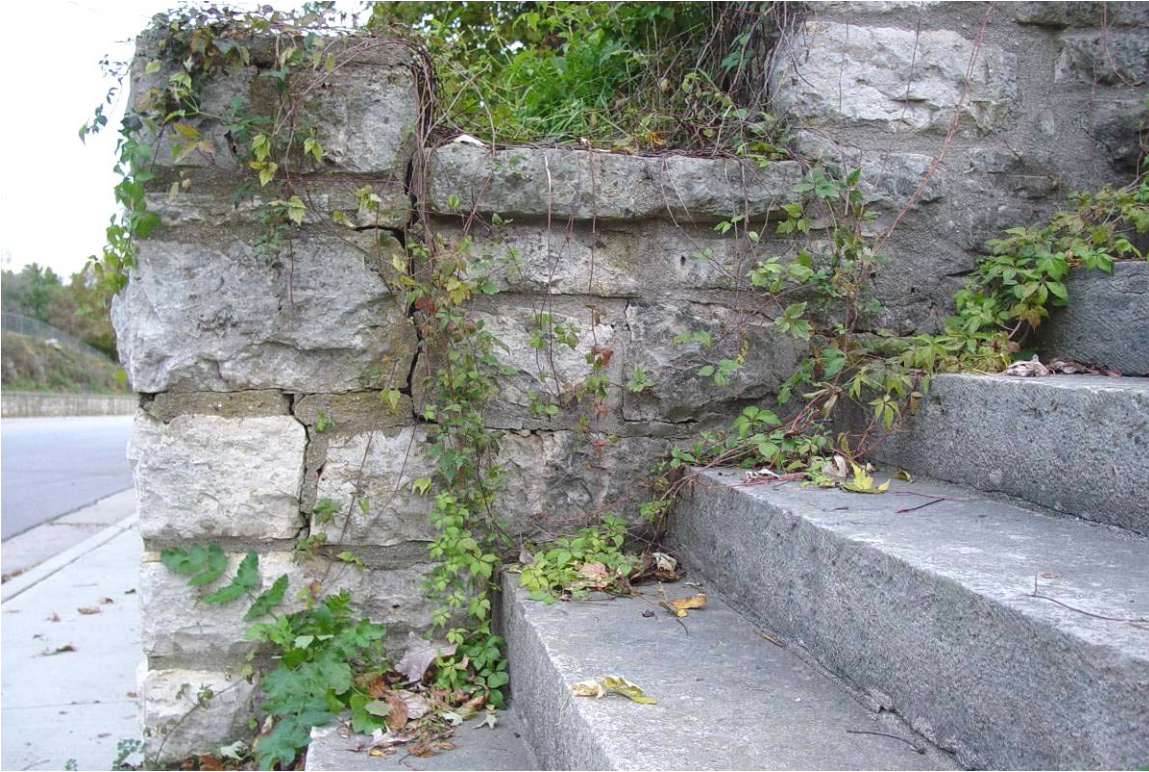
Plate 12. West retaining wall, north steps, facing south

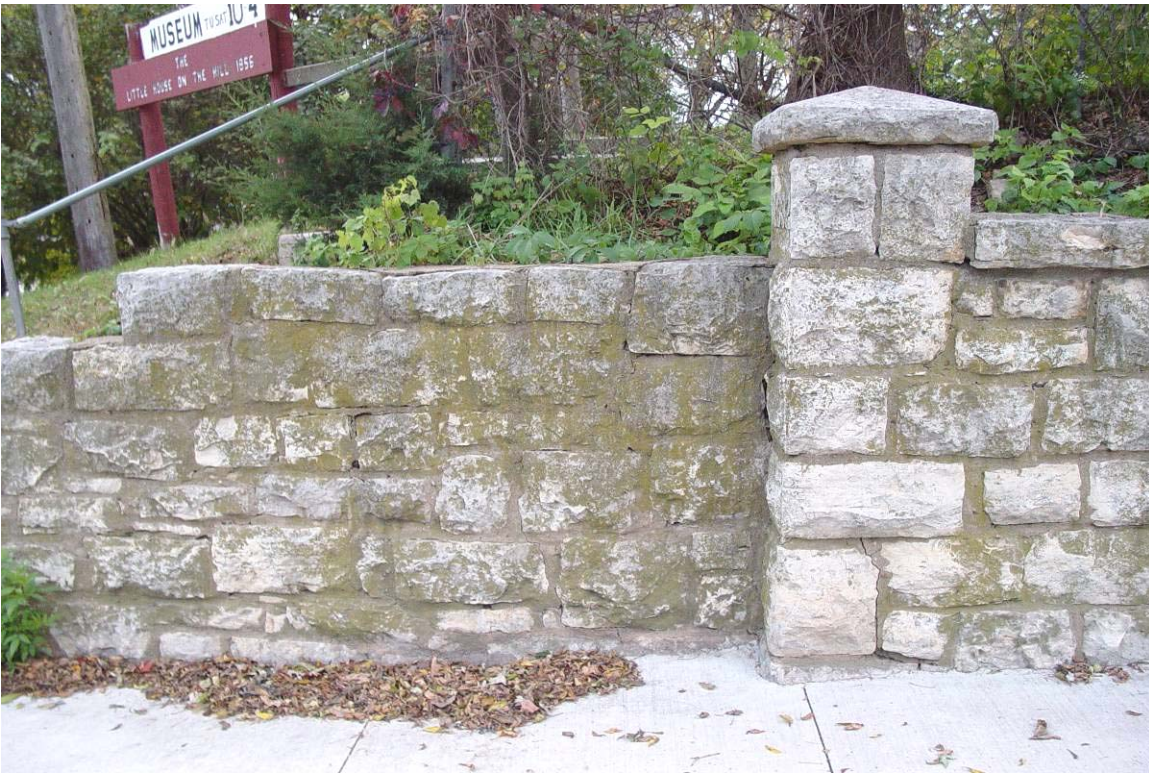
West Retaining Wall: The wall is in good structural condition, although the limestone slab steps at the south end are slightly out-of-plumb and there is some deteriorated masonry. The pyramidal finial at southern pier is of likely original gray limestone construction.

Plate 13. West retaining wall, south end, facing west

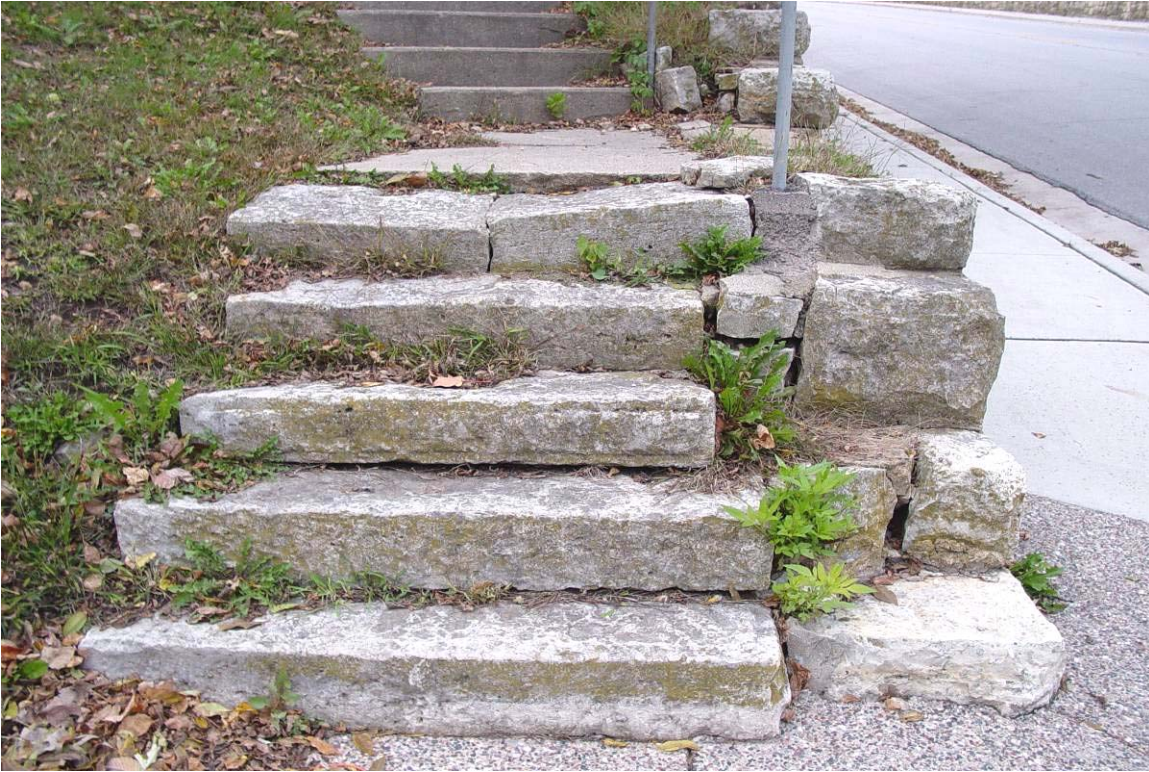
Plate 14. Masonry steps adjacent to west retaining wall, south end, facing north

West Retaining Wall: Repair the broken top step of south steps, remove and reinstall other steps level. Work with the Dodge County Historical Society to maintain the limestone steps leading to their properties at the north and south ends of the wall. Conduct further research to determine the style of the original railings. If no information is available, install simple galvanized pipe railing (all cost estimates listed under *Steps: West Wall Restoration*). **Work Period:** 3 - 5 years.

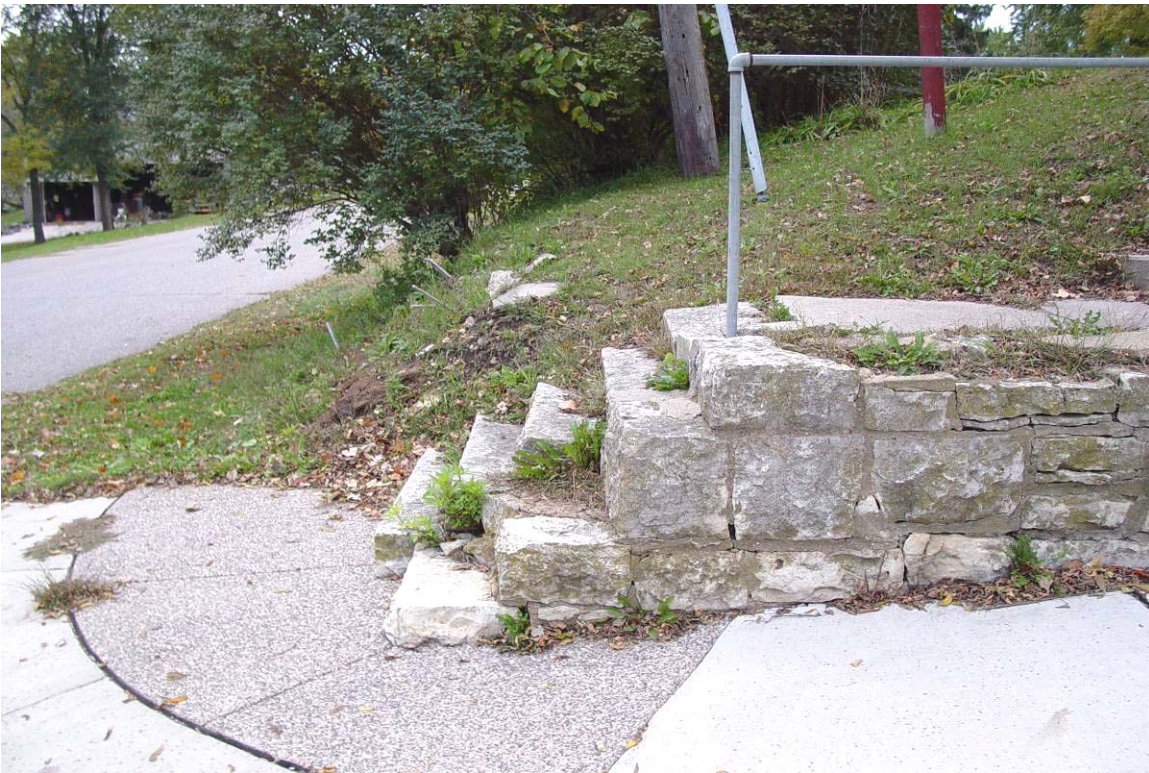
Plate 15. Masonry steps adjacent to west retaining wall, south end, facing west

West Retaining Wall: Replace all deteriorated masonry units (approximately 10) with locally quarried stone to match color and appearance. Remove all deteriorating mortar to a depth of at least 2" and repoint with Type N mortar. Re-level the steps at the south end of the wall (cost estimate listed under *Steps-stone*).

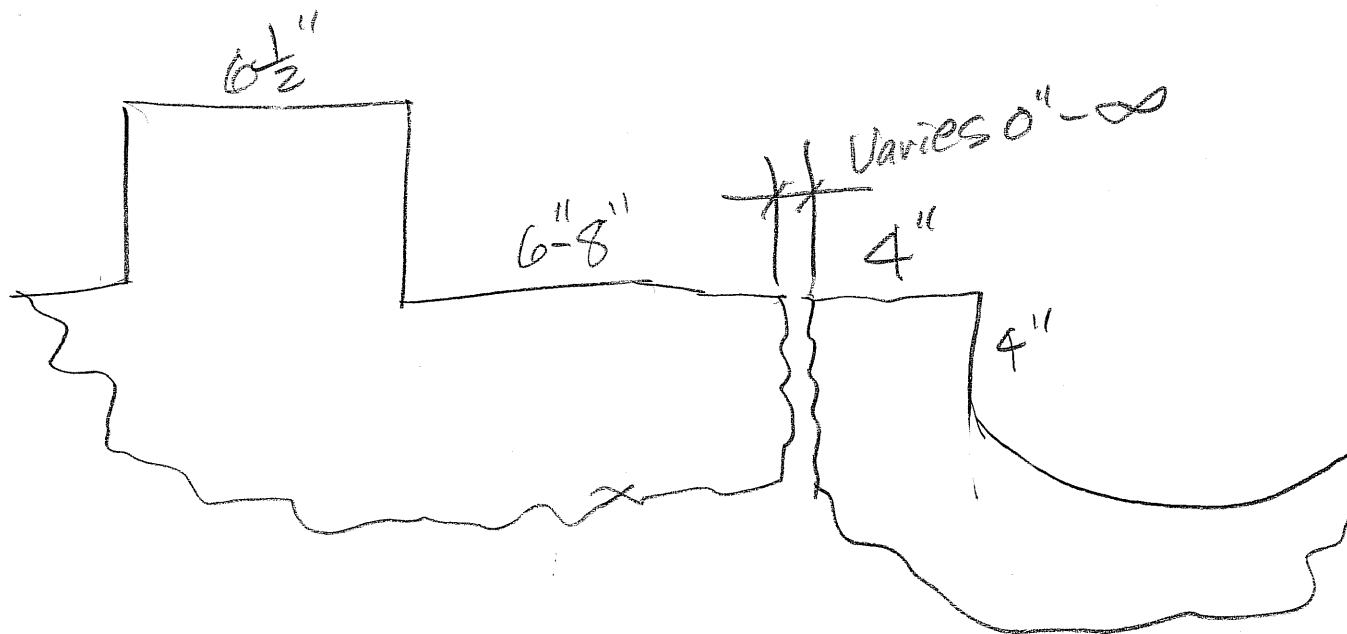
SECTION OF CONCRETE GUTTER

Gutter Dth @ Mantorville

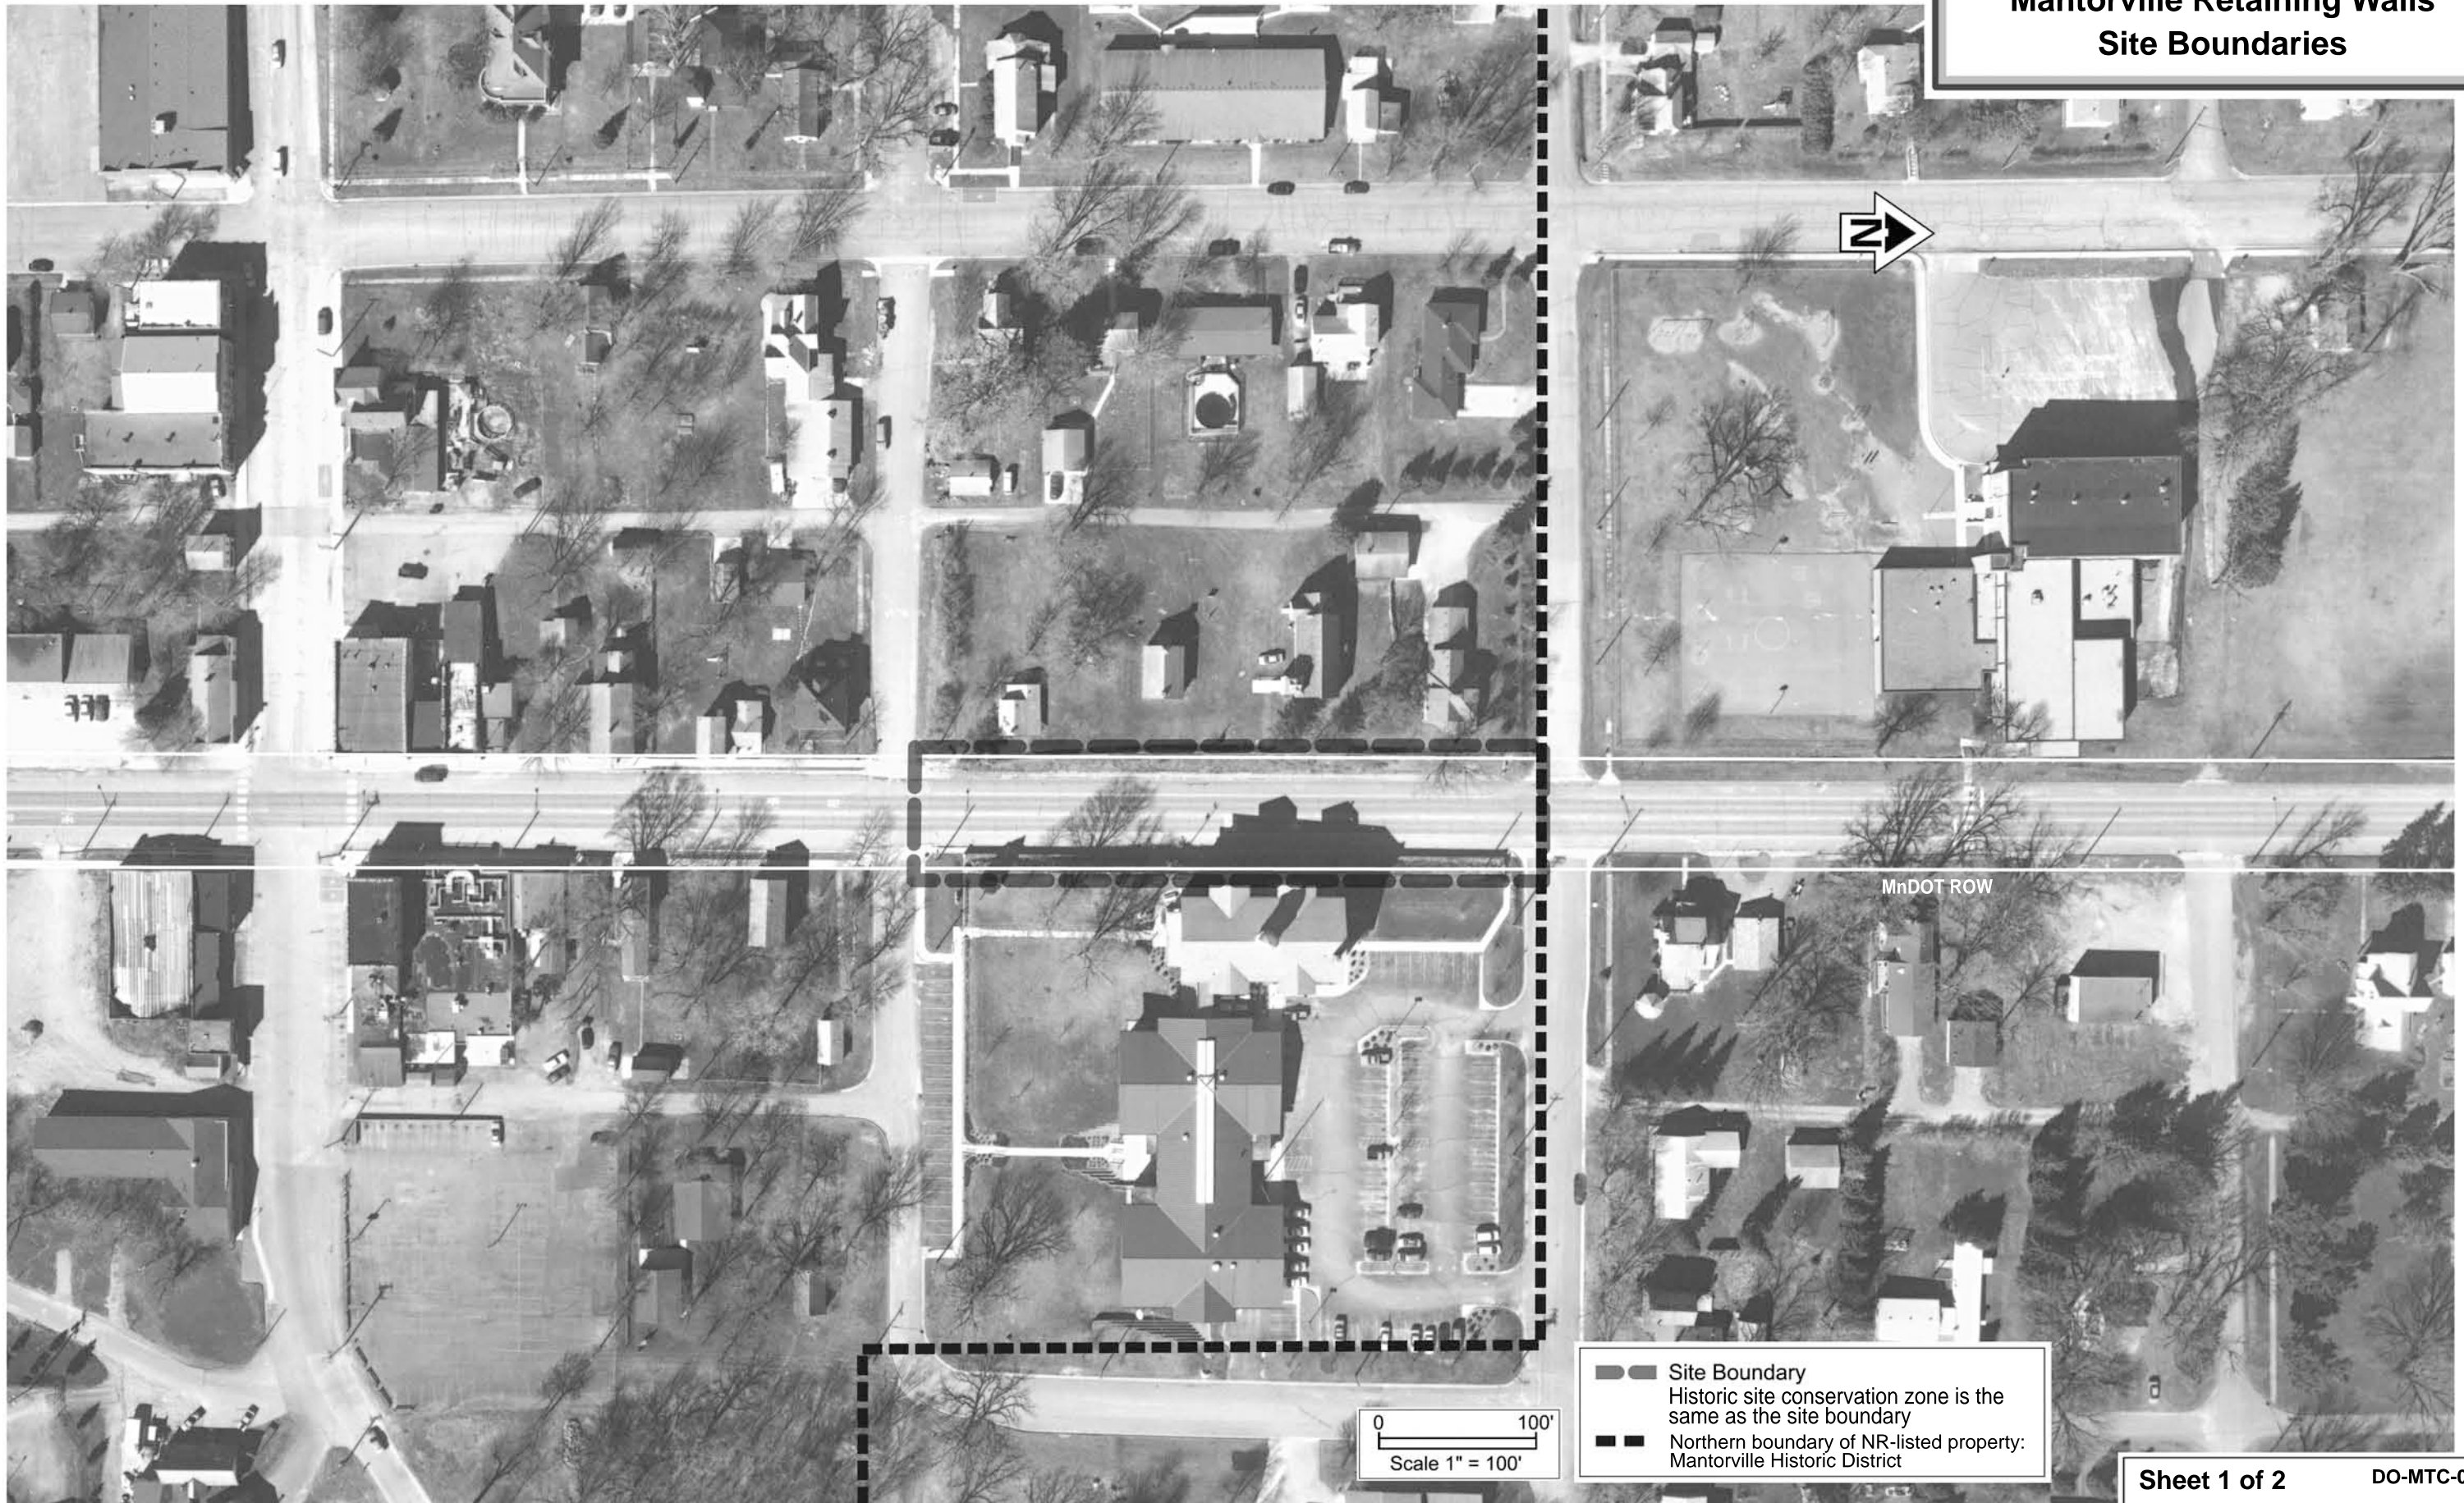
Mantorville Retaining Walls Site Boundaries

- Site Boundary
Historic site conservation zone is the same as the site boundary
- Northern boundary of NR-listed property:
Mantorville Historic District

It is recommended that the Conservation Zone boundary for the Mantorville Retaining Walls be identical to the site boundary, described above.
