Pavement Condition Report

Maple Lake Municipal Airport (MGG)

December 2018

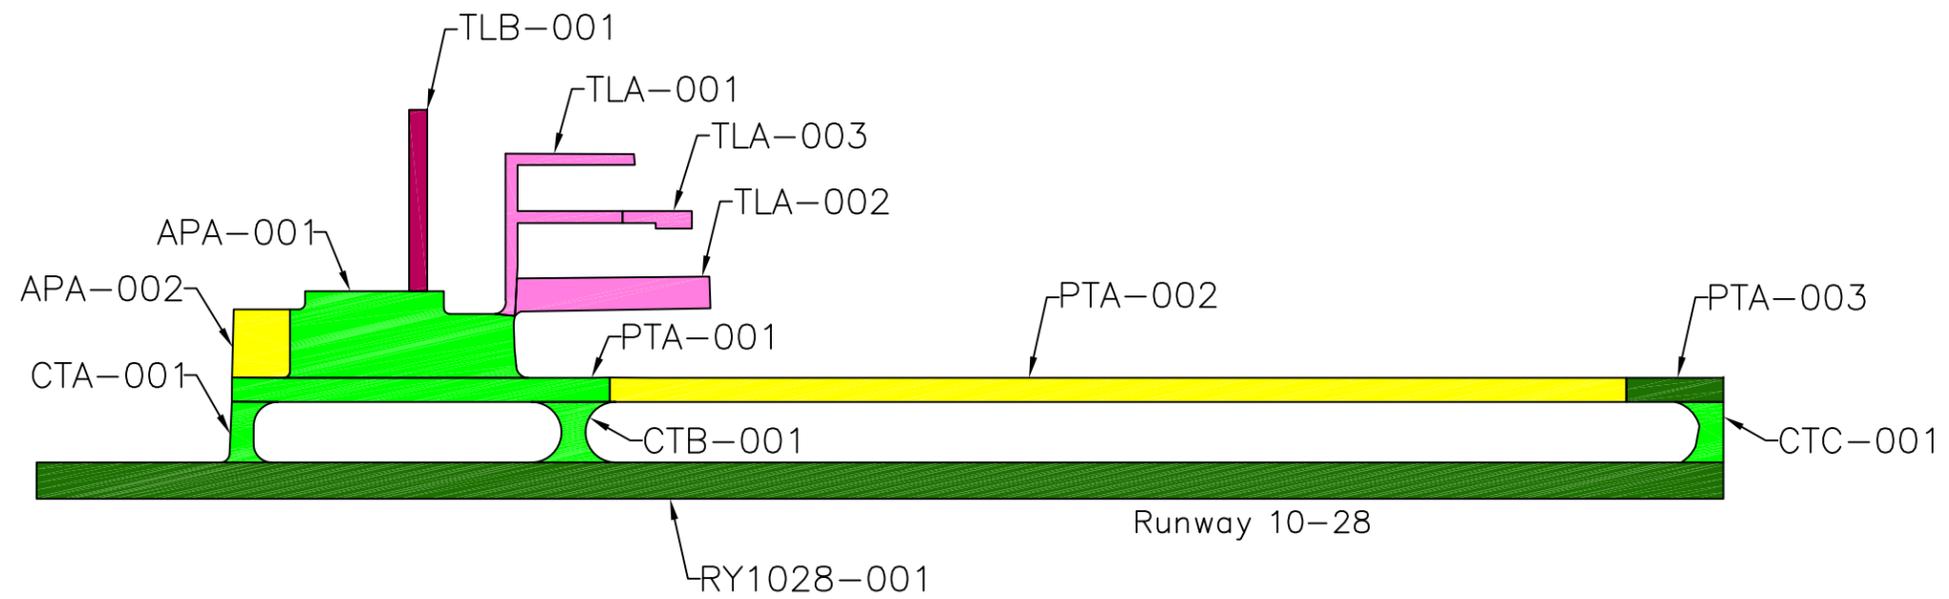
Figure 4. 2018 Pavement Condition Index Rating at Maple Lake Municipal Airport (MGG).

The results of the 2018 PCI inspection are presented in figure 4. The overall area-weighted, inspected PCI for MGG is 78. When summarizing PCI values, an area-weighted calculation is used instead of a straight mathematical average because the area-weighted calculations eliminate the skewing of the PCI due to the disparity of the section sizes.

⁶Higher than expected deterioration rate of 4.1 PCI/year due to the increase in the amount of medium-severity L&T cracking.

⁷Increase in PCI in each of these taxilanes due to slurry seal between 2015 and 2018 inspections.

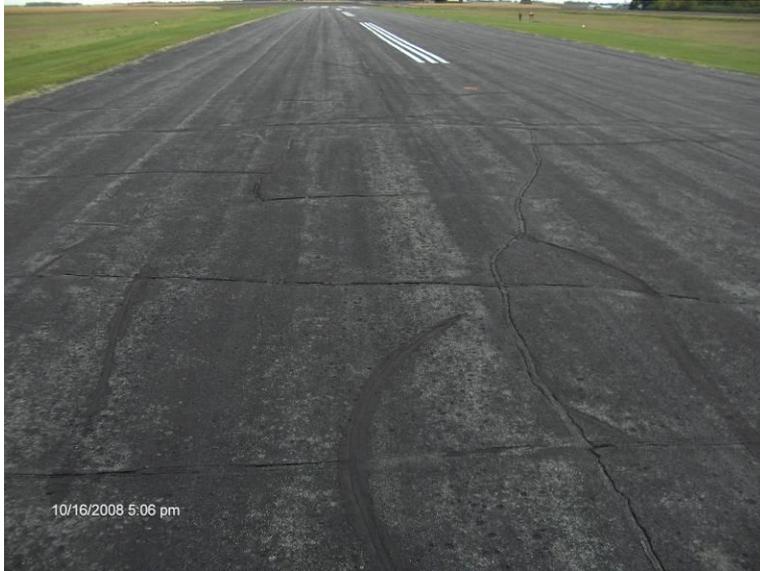
Example of Block Cracking

Block cracking is longitudinal and transverse cracking that has established a pattern of blocks ranging in size from 1ft x 1ft to 10ft x 10ft. This distress typically happens in older asphalt pavements and is an indication that the bituminous binder has lost most of its flexibility. The severity determination is basically determined by the crack width criteria defined for longitudinal and transverse cracking. Crack sealing typically is used to repair block cracking; however, the amount of required sealant can be extensive due to the high density of cracks.

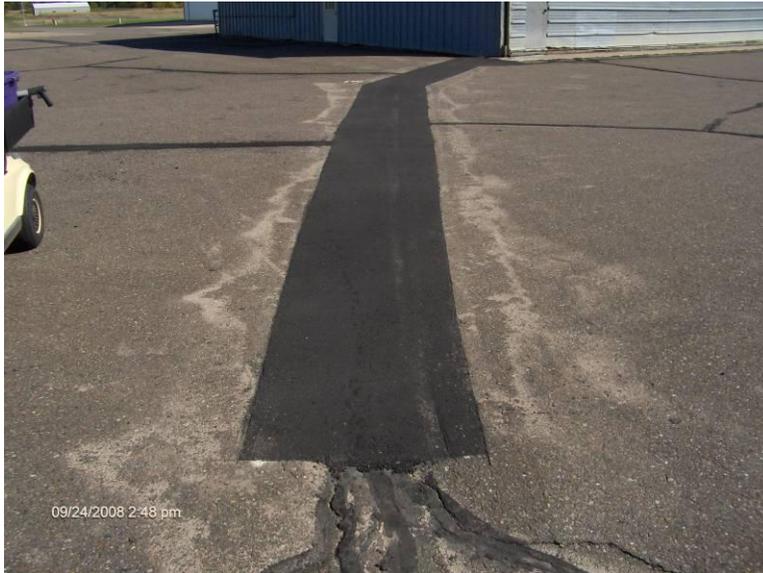
Example of Patching

Patched areas are defined when a portion of the original pavement is replaced with a material intended as a semi-permanent repair. A patch is documented as a defect because it is considered a break in the integrity of the pavement structure. Patches are constructed for a variety of reasons including utility repairs, correcting grade issues, and addressing a defect in the original pavement. The severity level of patches is determined by the amount of distress (i.e. cracking, depression, weathering/raveling, etc.) occurring within the limits of the patched area.

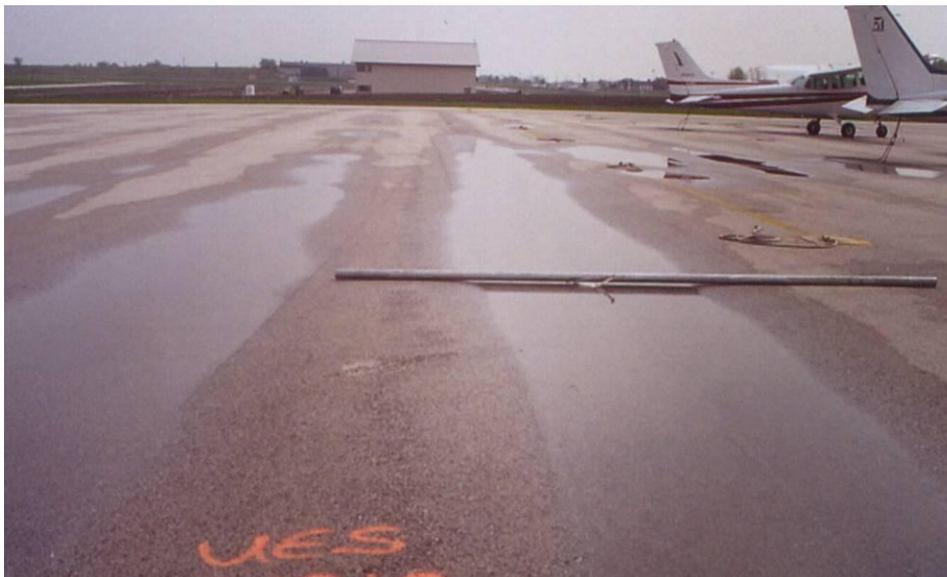
Example of Rutting

Ruts are localized, load related, areas of pavement having elevations lower than the surrounding sections. Rutting is due to base and subgrade consolidation, caused by excessive wheel loads or poor compaction. Ruts indicate structural failure, and can cause hydroplaning. At low severity, ruts have an

average depth of ¼ to ½ inches. At medium severity, ruts have an average depth of ½ to 1 inch. High severity, ruts have an average depth greater than 1 inch. Full-depth patching is the appropriate repair for ruts.
